# RESIDENTIAL BUILDING SURVEY

Horncastle  
Lincolnshire  
LN9 XXX

The property is Grade II Listed with a separate listing for the garden wall, as found in [BritishListedBuildings.co.uk](http://BritishListedBuildings.co.uk), English Heritage Building ID: XXXXX.

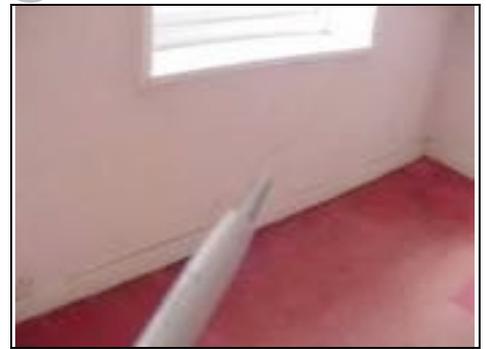
Right room

Cracking below window in right room

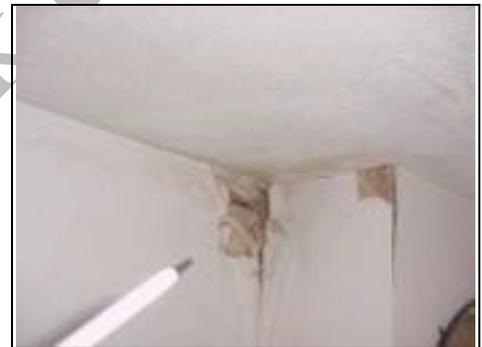
There is deterioration to the brickwork, for example we can see spalling has occurred and they have been repaired wrongly in cement mortar. Also, there have been poor quality repairs to the flashings.

Right chimney  
Poor quality repairs and plant growing

Leak from chimney one in top floor right room

Spalling brickwork from chimney falling onto roof

Poor quality cement repairs

**ANTICIPATED COST:** £5,000 - £10,000, access scaffolding will be required; please obtain quotes. Some of the poor quality work cement mortar that has been carried out will have to be unpicked, etc, which unfortunately makes this job harder than if nothing at all had been done, not to mention the extra damage that has been caused.

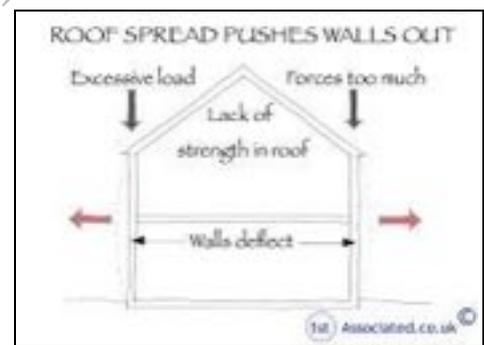
The original roofs have been replaced with a heavier concrete tile roof which can cause problems with roof spread and general changing of loading on the property.

The right roof is a hipped roof, which are integrally unstable and effectively lean on themselves for support and can result in the pushing out of external walls.

Roof spread

**ACTION REQUIRED:** We would recommend the entirety of all the roofs, particularly this main roof, are fully lit, with access ladders added and boarded out to allow a close inspection. The inspection we carried out was by torchlight and had limitations.

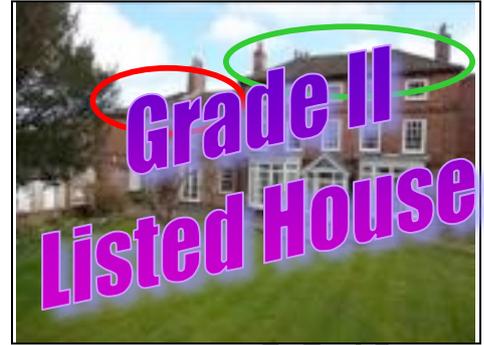
We particularly noted the left side of the roof where there seems to be problems of gauging the tiles correctly. This has resulted in a doubling up of tiles to the rear of the property and an out of alignment of the tiles to the front of the property. We believe that this has contributed to the dampness that can be seen inside to both the ceilings and the walls; further investigation needs to be carried out but fundamentally the roof gauging is the problem.

Right roof (green)  
Left roof (red)

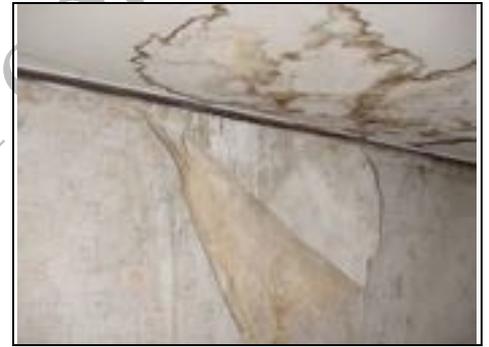
Badly gauged/tipping of concrete tiles/no tilting fillet to left side of front roof

Leak to top floor left bedroom

**ACTION REQUIRED:** Whilst the work to the chimneys and guttering is being carried out we would recommend that sections of the left hand roof are investigated to see the condition particularly to the perimeter of the roof (we would also recommend that you investigate the right side of the roof as well) so you can get to understand what is happening with the roof construction particularly on the left side.

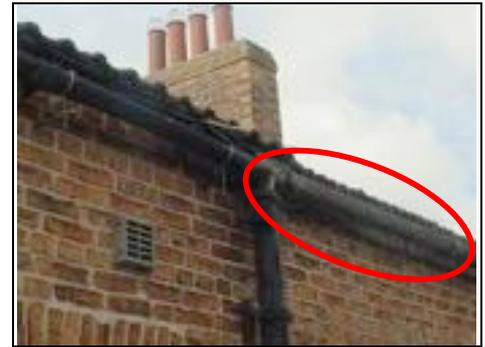
The property has a mixture of gutters and downpipes of cast iron, plastic and asbestos (noted to left and rear part of property - there may be more asbestos).

Asbestos guttering to rear

**ACTION REQUIRED:** General maintenance and upgrading of the gutters and downpipes. You need to do a physical check on this property to ensure the rainwater is being captured by the gutters and downpipes and taken away. We would recommend that all the asbestos gutters are removed with the appropriate safety measures (it would be best to do an asbestos check on the whole property). Our insurance company requires us to advise we are not asbestos surveyors and advises us to recommend asbestos surveyors are instructed and that you have your own asbestos survey carried out.

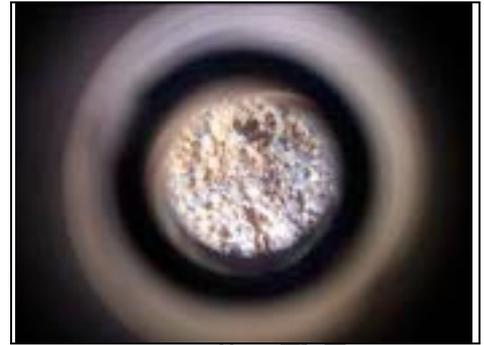
Microscope photo of the brickwork indicating salts discharging down the walls meaning the gutters / roofs are not working properly

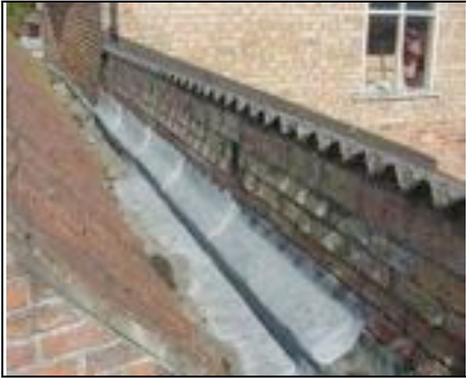
There are valley gutter problems to the garage/workshop area which we can see part has been repaired in lead but this needs double checking to ensure it is watertight.

Valley gutter repaired that was allowing dampness into garage

**ACTION REQUIRED:** This problem may well have been resolved although we were still getting some damp meter readings in this area. We would suggest that you speak to the owners and ask them when the roof work was carried out and whether there is any form of guarantee. We suggest that a dye water test on the flat roof and the valley gutter areas to check and test it is watertight (use a coloured water so you can establish if it is a new leak or not). If it is not watertight then patch repair and we would recommend that if the areas are replaced that an insulation cut to falls is used as well as a high performance felt.

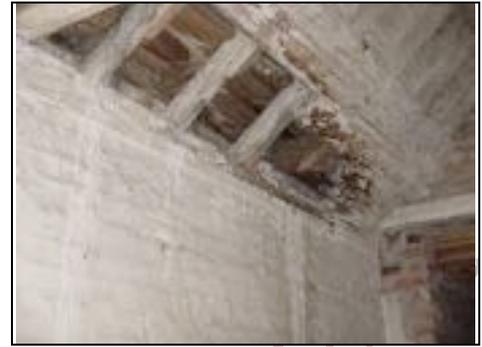
Valley gutter problems, part repaired in lead but needs double checking this is watertight

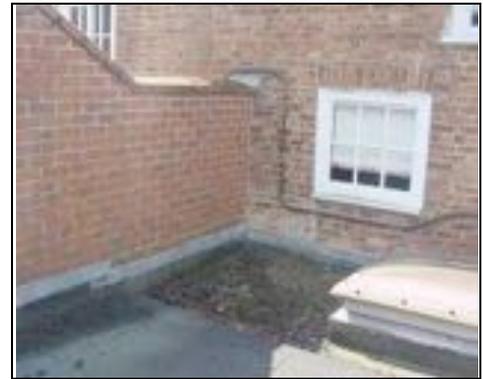
Flat roof

Considering the flat roofs in more detail, the flat roofs to the rear of the property are coming to the end of their natural life. Of course such roofs could be patch repaired forever and a day however the fundamental problem with this flat roof is that it is a flat flat roof and there is a fair amount of leaves, etc on the roof which is not helping matters. The basic problem we feel is the lack of a fall.

**ACTION REQUIRED:** We would recommend that insulation cut to falls is added to the roof using a high performance elastomeric felt.

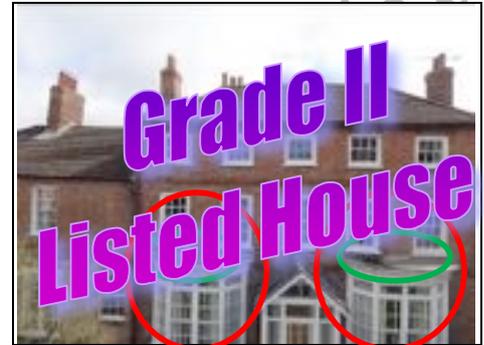
There are two bay windows to the front of the property. Both bay windows have large long beams/lintels underneath them which are likely to be timber. We can see that there has been minimal movement to the left bay and normal movement to the right bay which is directly below the area of brickwork movement. Nevertheless we would like these beams to be checked and inspected as they can be weak areas.

Bay windows (red ovals – with roofs circled in green)

**ACTION REQUIRED:** Open up the areas around the bay window and expose the beams/lintels and check the condition of the beam.

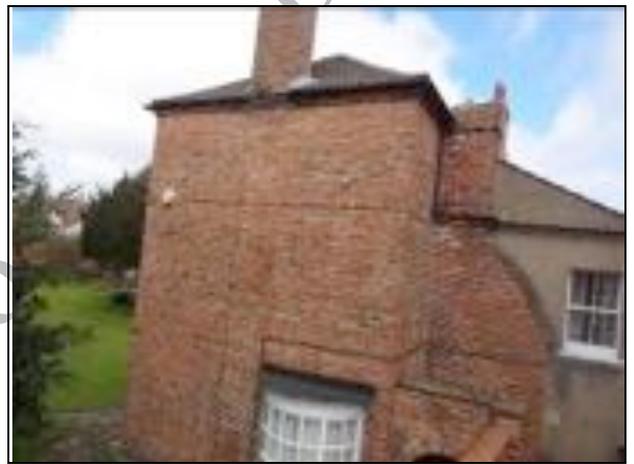
The walls have been repointed in a cement based mortar; this should be replaced with a lime based mortar as it is taking the face of the brickwork away as the mortar mix is too hard and ultimately will create what we term as spotted dog effect on the property. Unfortunately worse still, some of the bricks that have had the faces damaged have had a cement covering on them which should be removed and either the bricks replaced or taken out and reversed if suitable.

Spotted dog effect

**ACTION REQUIRED:** We would recommend you find a bricklayer who is experienced with older properties and lime mortar to carry out repointing of the brickwork over the summer months for the next few summers using a soft brush to remove any cement mortar. The only good thing generally with cement mortar repointing is that it does ultimately fall out on its own. Replacing the cement mortar with lime mortar will help the dampness problems that we are finding in the property which in turn are causing problems with the floor joists that are embedded into the walls.

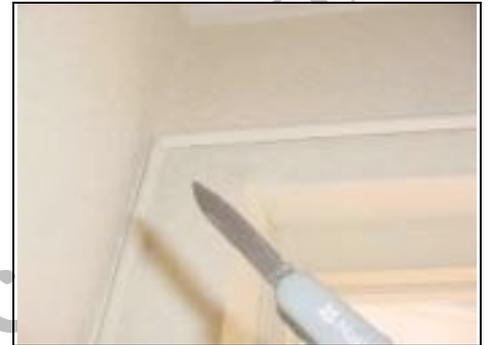
Cracking to rear conservatory/porch area

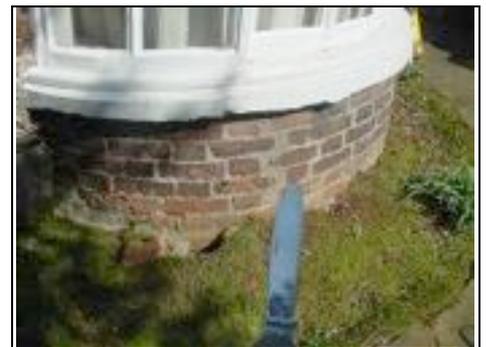
We believe the crack to the bow window relates to the movement to the rear right side of the property.

Crack to front bow window

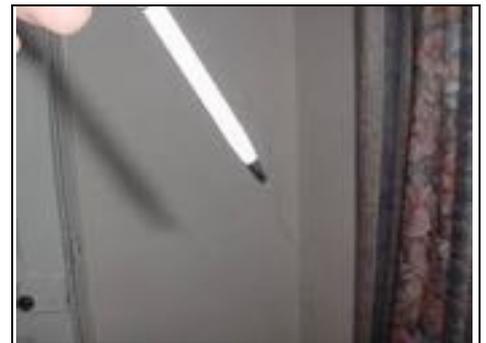
In several cases there is cracking between brickwork structural walls and studwork walls.

First floor left room of main building. Crack between studwork and main wall

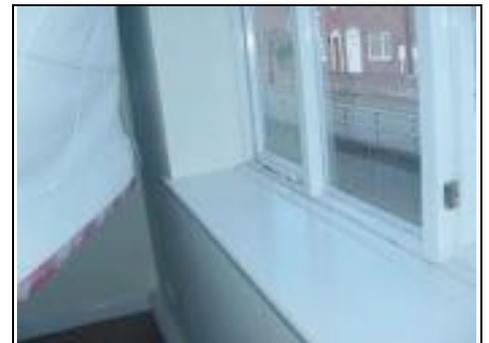
We also note there is plastic double glazed windows to the rear of the property which of course are not allowed on a listed building without consent as indeed timber windows are not allowed without consent.

Modern 1970's timber windows to left building

**ACTION REQUIRED:** Approach the owners/Conservation Officer and ask whether consent was obtained and also if there is a specification available on the quality of windows. Unfortunately windows that do not have any structural strength will cause problems on the rear elevation in due course. When work on the windows is taking place you need to also check the lintels above the windows as these are likely to have been timber originally and may still be in place. You need to check and ensure that the window sill detail is appropriate for this age, type and style of building. For any windows that you do put in get agreement with the Conservation Officer.

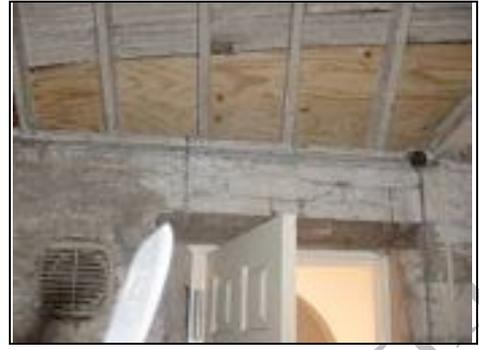
Timber lintel in coal bunker which indicates there may be other timber lintels

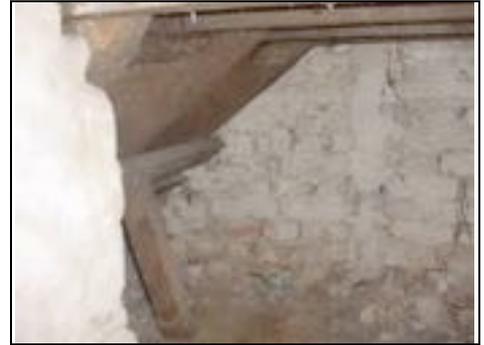
We noted some of the staircases as we went around the building moved and would benefit from being secured. It may well be that they are bedded into the walls which as we have mentioned are fairly damp and have over time deteriorated or it could be that they need a general overhaul.

Stairs move

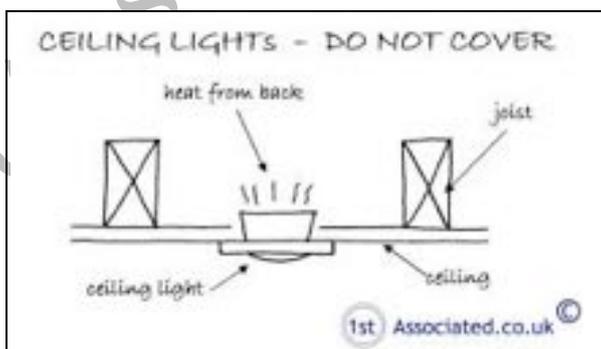
The property has 1970's electric lights to the ceiling. In some instances these can cause problems as the heat given off has in some cases lead to outbreaks of fire; these tend to be in the older type of ceiling lights and we recommend that where ceiling lights are used that the rear of the light is not covered; this is particularly the case in rooms with a loft space above it where stored items are placed in it.

Ceiling lights

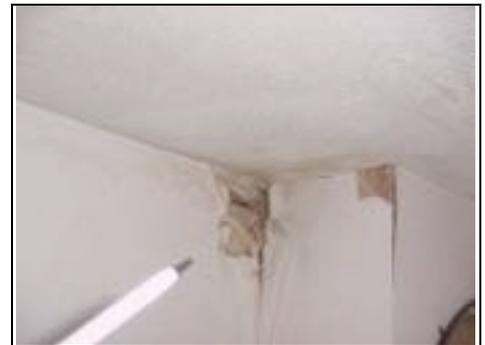
Right Chimney

Leak from chimney one in top floor right room

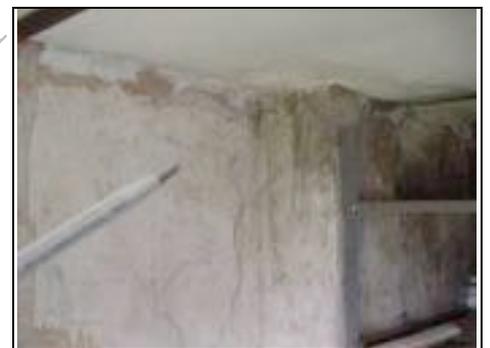
Front Left Chimney

Chimney Two leaking  
top floor left bedroom

**ACTION REQUIRED:** Please see our comments in the Executive Summary.

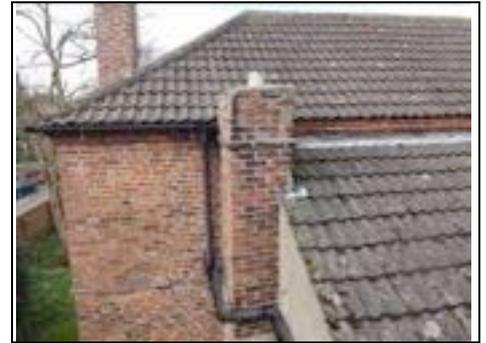
Rear Right Chimney

This chimney is brick finished with a lead flashing and two flues. From what we could see from ground level it looked in below average condition considering its age, type and style. This is also part retaining wall.

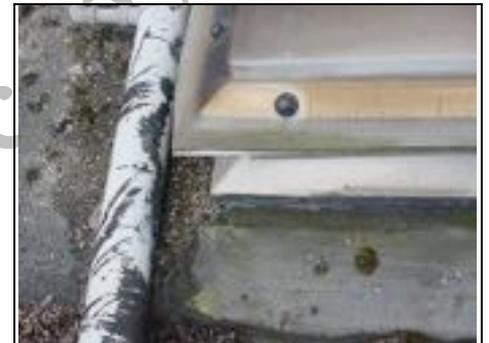
Roof window repaired

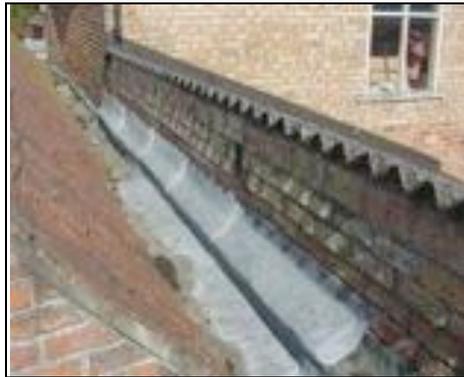
Valley gutter repaired that was allowing dampness into garage

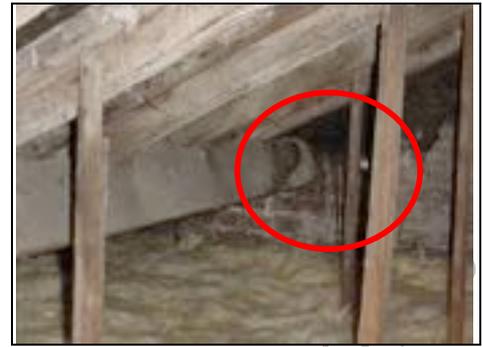
Dampness

**ACTION REQUIRED:** We recommend the roof is vented. We would recommend the roof is fully lit and boarded and then we would be happy to view the roof. The only way to be 100 per cent certain is to have the roof cleared and checked.

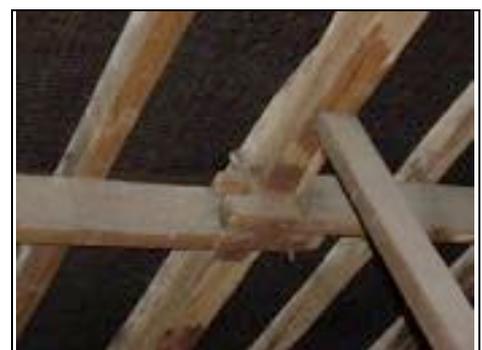
There looks to have been work with adding of purlins and repairs to purlins. We can see metal braces and ties and also supporting timbers to the purlins. Purlins are generally added to give extra support to the common rafters.

Strengthening 'braces' on purlins

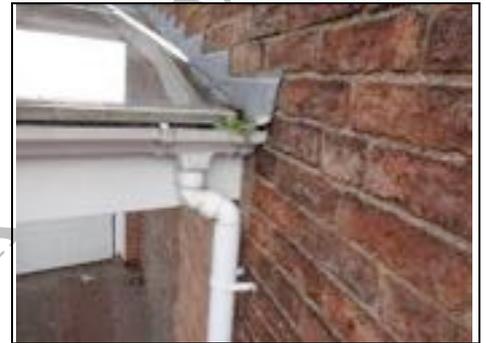
We noted that the property has a mixture of cast iron gutters and downpipes and modern replacement plastic gutters and downpipes. Where these two materials are mixed there are often problems where they join and also in the falls to the outlets.

Plants growing out of guttering

We also recommend that the gutters and downpipes are cleaned out, the joints are checked and the alignment checked to ensure that the gutters fall towards the downpipes.

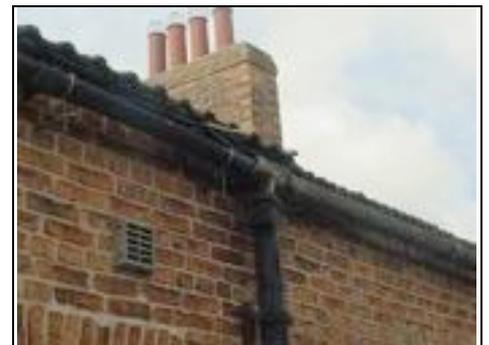
Asbestos guttering to rear

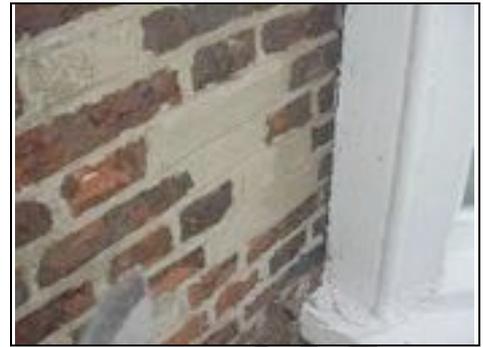
Cement repairs

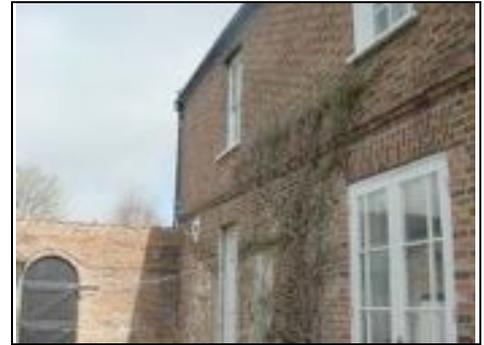
There is ivy growing on the building which can cause damage, we would always prefer that a trellis is used to separate it from the building.

Ivy

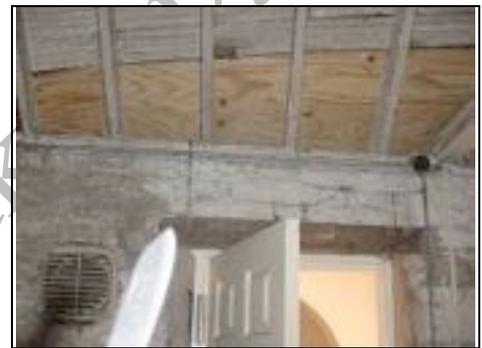
Timber lintel in coal bunker which indicates there may be other timber lintels

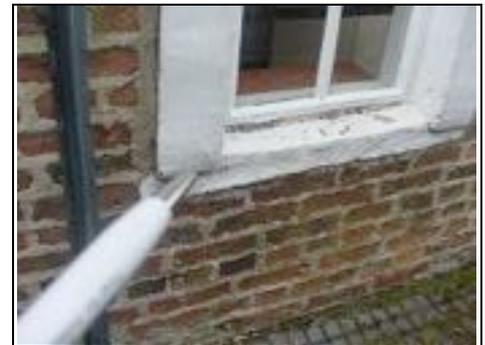
The property has single glazed timber sliding sash windows with and without sill details, older windows tend to have minimum sills. The windows are generally in average to poor condition with some wet rot, cracking and flaking paintwork.

No sill detail

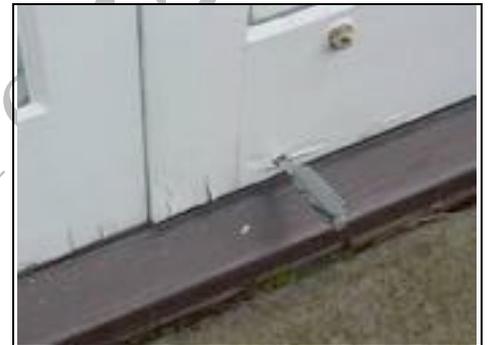
Wet rot to front door

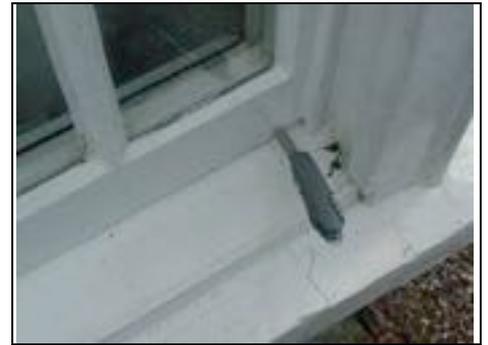
Wet rot in the front sliding sash window

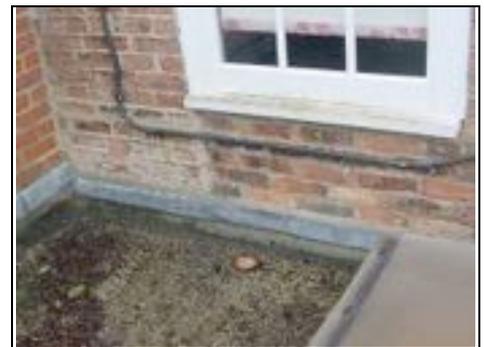
Plastic windows to rear have reduced sill width which may be a requirement of the listed building/conservation officer

**ACTION REQUIRED:** We would recommend a monetary discount on the property and also discussions with the Listed Building/Conservation Officer as to what they are and are not happy with on the property generally with regard to modern alterations.

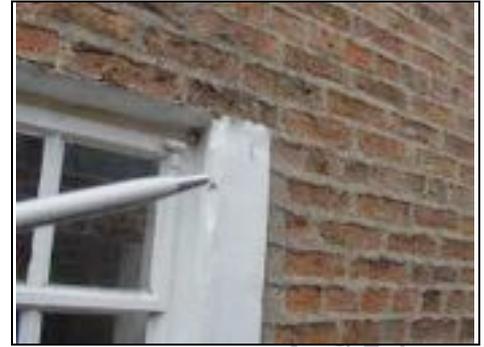
The property has metal windows to the rear where we could see concrete repairs have been carried out around them. Some metal windows can be the older style windows added by blacksmiths, etc. This does need further investigation.

Concrete repairs to rear metal windows

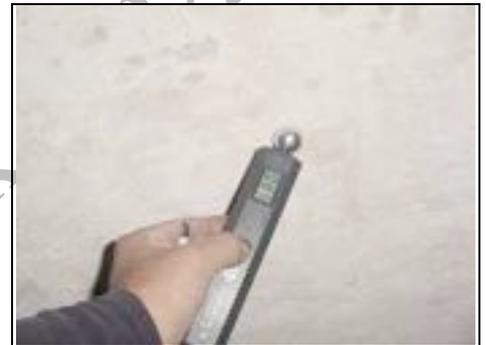
Dampness fairly high

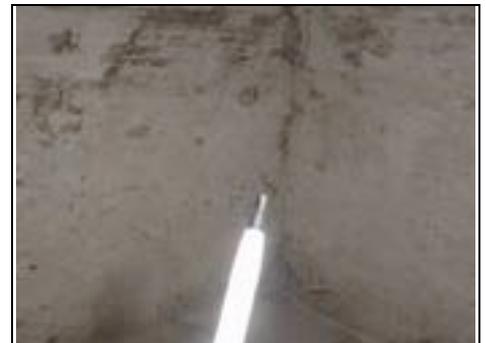
Cracking to front left corner

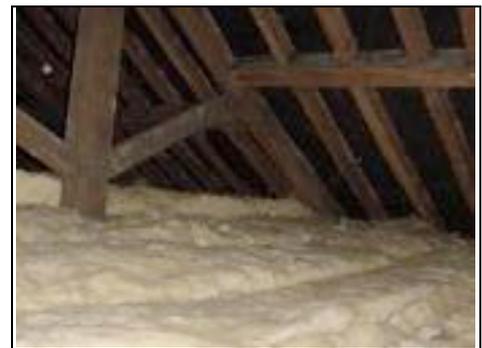
Over-insulated?
