RESIDENTIAL BUILDING SURVEY

Barnsley

Mrs X

INDEPENDENT CHARTERED SURVEYORS

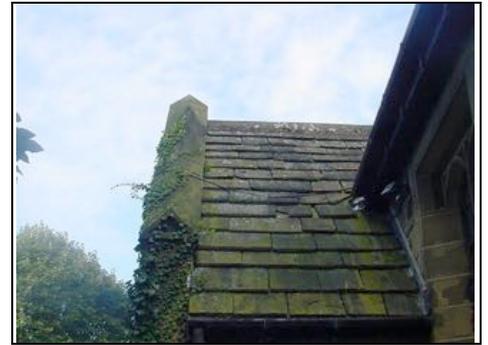
Damaged stone slabs to roof

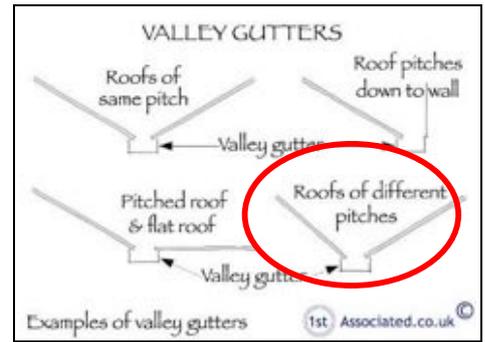
Flashband is a sticky backed felt, which is best used for temporary repairs only.

Two main parapet walls with Flashband repairs (red ovals) and valley gutter (green oval)

ACTION REQUIRED: Replace felt and Flashband with lead flashing. This work can be carried out over the next few years with the exception of the Flashband to the pitched roof to the nave end which looks to be allowing water in and the rear parapet wall to the front of the chancel which looks to be deteriorating rapidly.

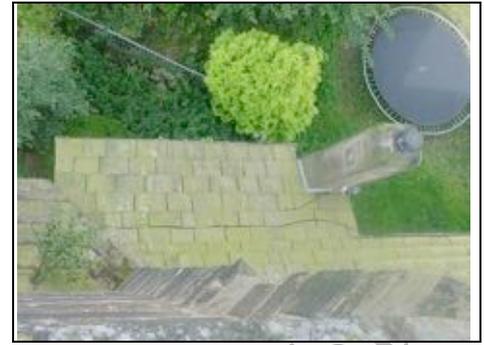
There seems to be problems with the roof adjacent to the tower allowing dampness in to the store room below, also causing staining on the exterior of the property. As this is a store room you may wish to leave this work to a later date, the longer it is left of course the more expensive it may be to repair. We were advised by the existing owner that they had not carried out any work in that area.

Roof adjacent to tower covered with moss

ACTION REQUIRED: Check roof adjacent to the Tower and replace stone slabs as necessary, including the battens and fixings beneath and install a lager hopper head.

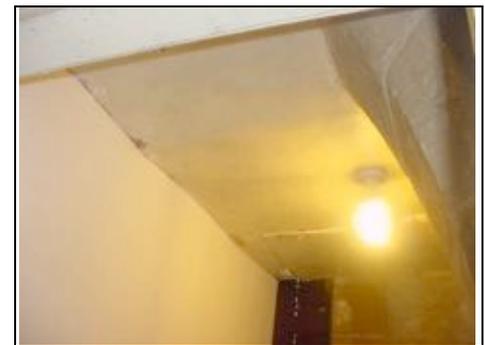
Staining to store room roof

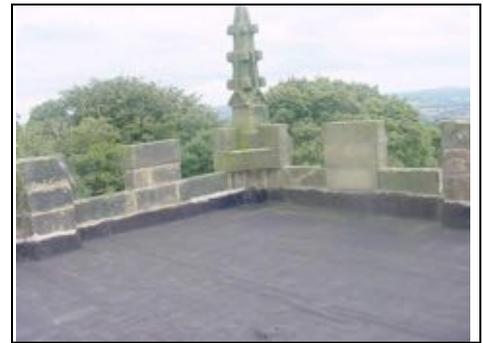
We can see that repairs have taken place to the lead flashings but further repairs will be needed.

Repairs have taken place to the Tower parapets

ACTION REQUIRED: Further repairs will be needed to the flashings, also some securing of the stonework.

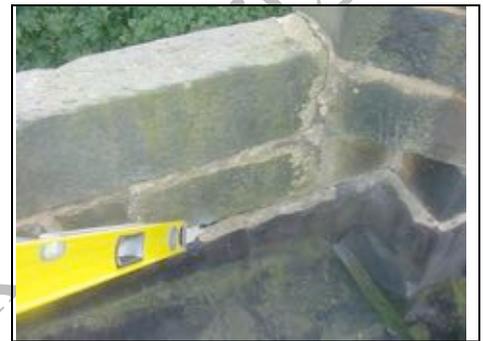
Pointing coming away from the flashing

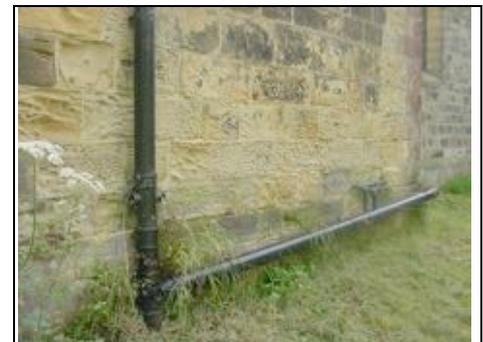
The property has coursed stonework with relatively thin joints. Originally the pointing would have been a lime mortar with gilleting (more about this in the Walls Section). This has then been repointed incorrectly with a cement mortar, which in turn causes deterioration.

Damaged stonework

ACTION REQUIRED: General repairs to the stonework. Repointing in a lime mortar needs to be carried out over many years.

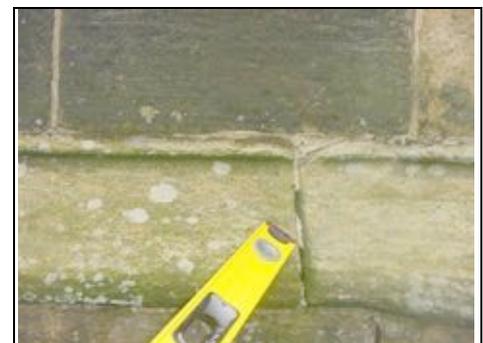
Weathering to pointing

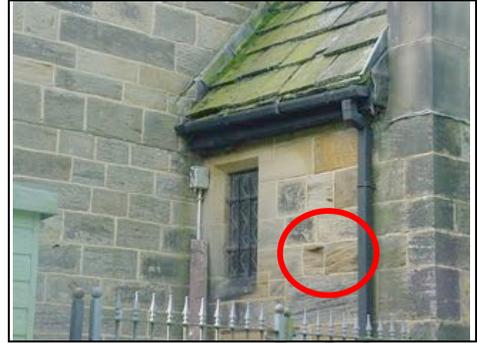
Damaged stonework to north side

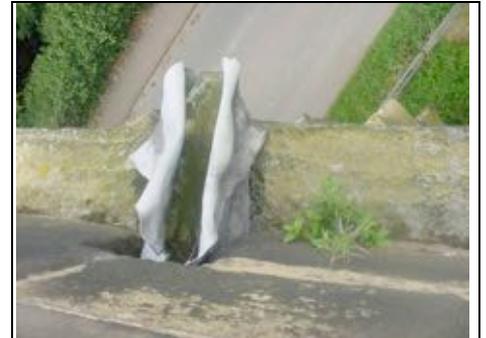
Tower rainwater head that discharges rainwater down the building

This discharges rainwater down the building, which in turn will weather the mortar and stonework. Without completely changing this detail (which we suspect the Conservation Officer / Listed Building Officer would not allow) you do need to be aware that you will have to carry out constant repair work.

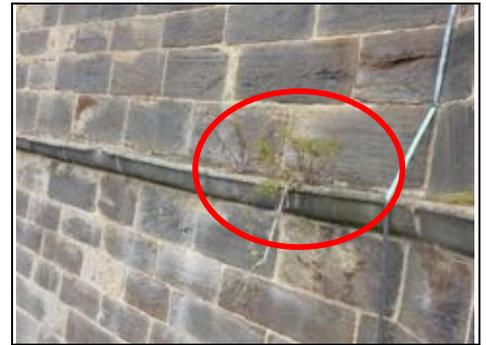
Some of the detailing on the property means there are ledges. Ledges allow water to sit on it, which means you then have lichens, moss, plant life and vegetation growing on them which can cause deterioration to the stonework.

Plants growing out of the ledge
Aerial view – 360 photo

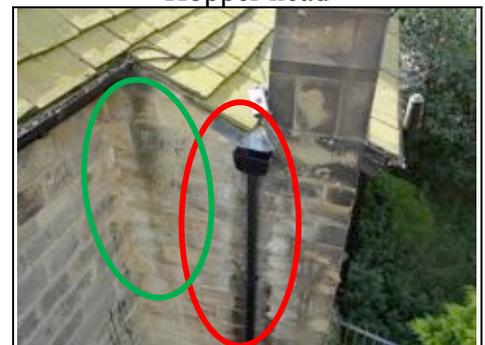
We noticed that some of the roofs seems to be discharging rainwater down the property. It may be because the gutters are full and we recommend these are cleared. It may equally be there is simply too much water for these gutters and hopper heads. We can see staining particularly to the rear of the church.

Leaking hopper head– staining down wall (red oval) and overflowing gutter (green oval)

ACTION REQUIRED: We recommend the gutters are cleaned.

You need to stand outside next time heavily to assess that all the rainwater is getting away from the building adequately. Repair and amend as required.

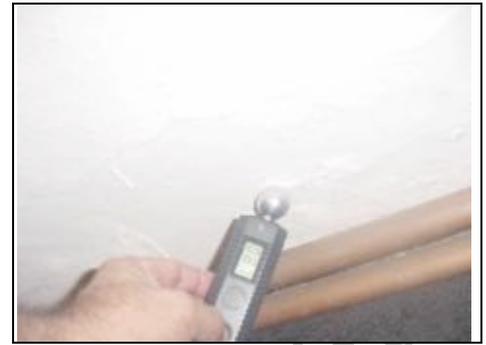
We found significant rising damp to most areas of the property when we tested the walls with a damp meter.

Testing for rising damp

ACTION REQUIRED: There are ways of reducing the dampness, such as reducing the ground level around the property. You can add dry lining/false walls in to hide the effect of the dampness, however as you could see on the day, the dampness effect is relatively minimal visually, with the blistering of paint and plaster in some areas. We would add that we note that a plastic paint has been used which will not help the natural drying process of the stone walls internally.

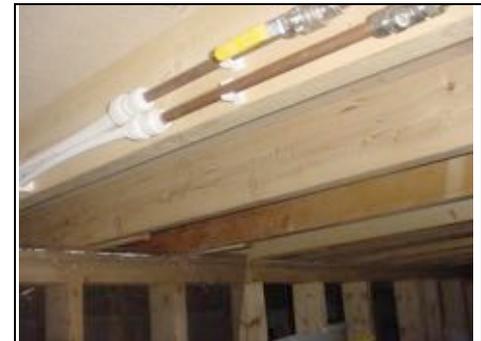
Pipe wise, we noticed a mixture of plastic and copper which we are not particularly keen on as they are prone to leaking where the two join and we suggest that you convert everything to being one or the other, as it can cause differential movement if they leak.

Mix of plastic and copper pipes under the lounge

ACTION REQUIRED: We would recommend you monitor any areas where plastic and copper are mixed and we would change to copper should there be any problems.

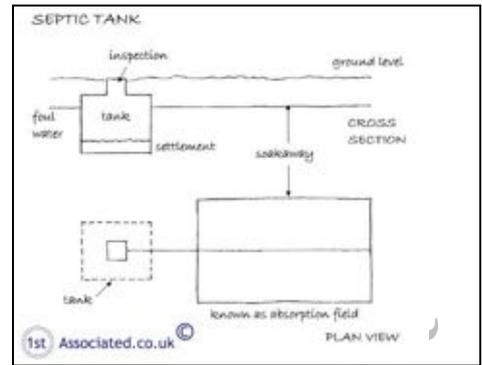
Septic tank

As we have not opened up the septic tank you can take the current owner's word for this or you can ask for whoever emptied it last to comment further.

ACTION REQUIRED: We always recommend septic tanks are emptied before you legally commit to purchase the property so they can be inspected. We were advised that this was a modern glass reinforced plastic (GRP) septic tank as opposed to an old brick one.

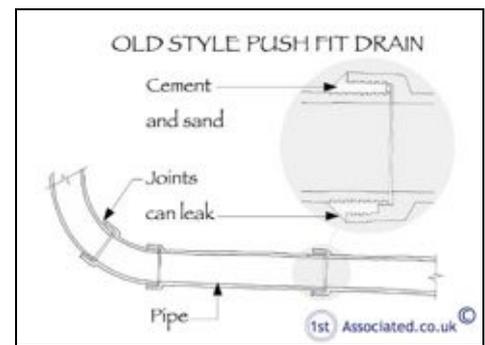
In older properties, such as this, drainage was often push fitted together rather than bonded together which means that they may leak over the years. Whilst we ran the tap for 15 minutes without any build up or blockages the only way to be 100% certain of the condition of the drains is to have a closed circuit TV camera report.

Push fit drain

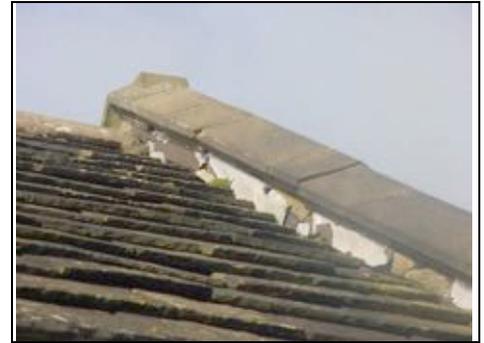
Deteriorating flashing on parapet

ACTION REQUIRED: Please see our comments in the Executive Summary.

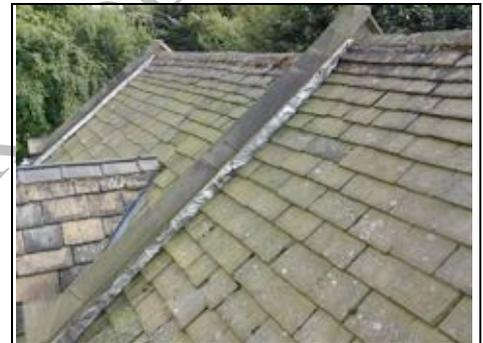
Flashband repairs on parapet

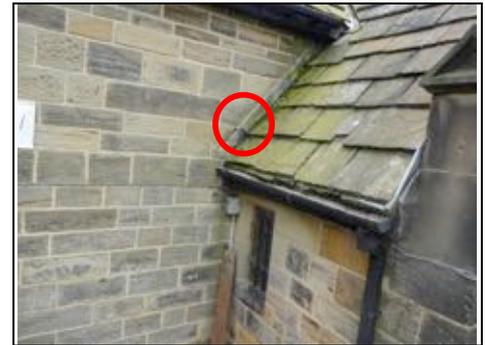
Extra lead added (red oval) and missing lead (green oval).
Leadwork needed
Aerial view – 360 photo

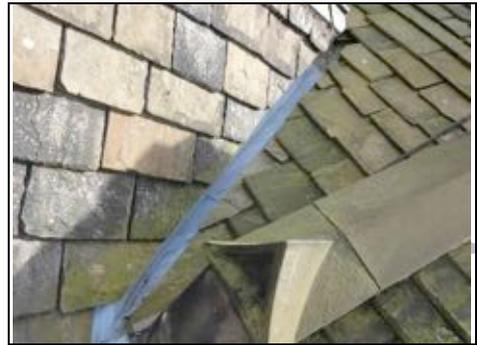
Repairs to valley gutters
Aerial view – 360 photo

ACTION REQUIRED: Specifically ask the owners what valley gutters they have replaced and repaired over the years and ideally get receipts in relation to the work.

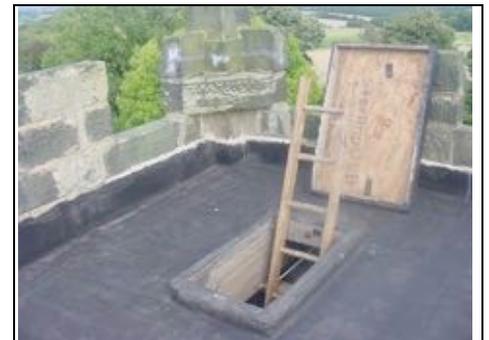
The flat felt roof has been repaired many times and we can see there are problems relating to the flashings which have been repaired.

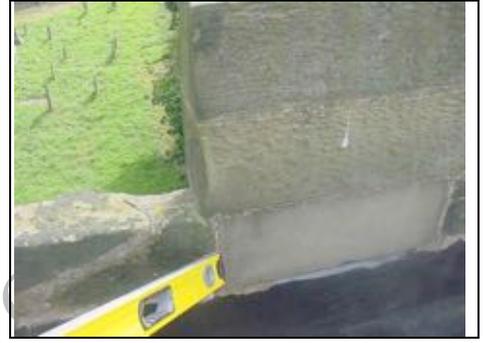
Old repairs to parapet visible

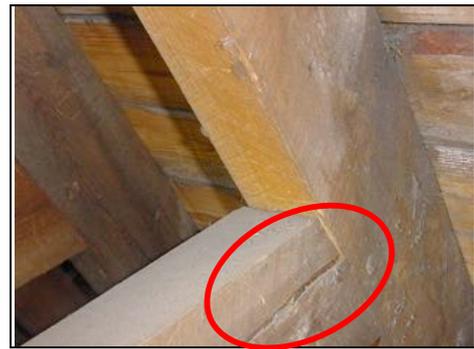
Splits in collar

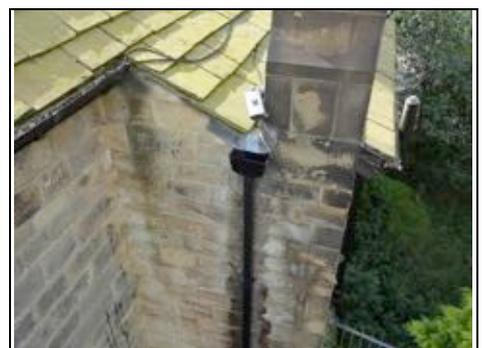
Close up leaking hopper head and gutters, discharging down the wall
Aerial view – 360 photo

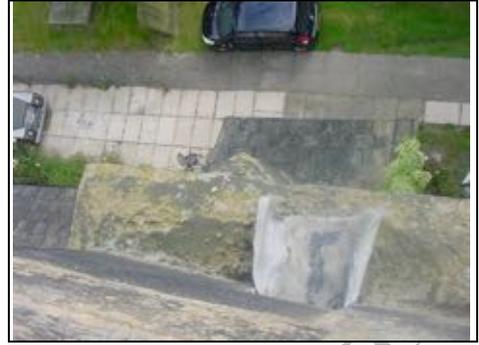
Water is discharging from the gully on the Tower all the way down the stonework to the base, causing deterioration.

Rainwater discharging from tower flat roof via lead gully

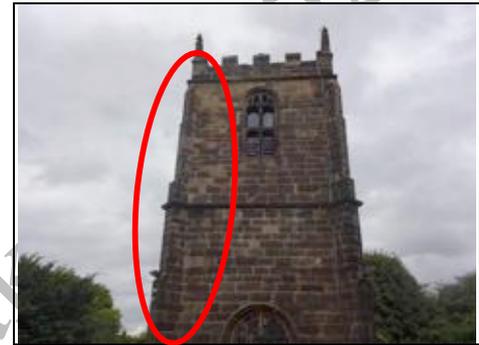
Water discharges down Tower

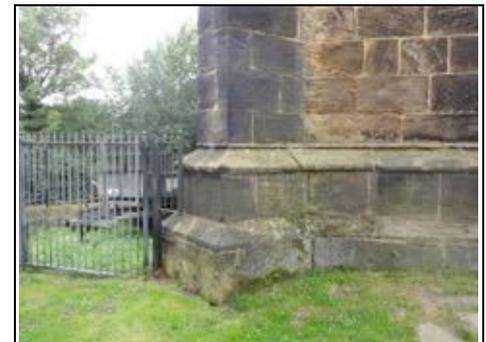
Water runs to the base where there is worn out pointing and deterioration to stonework

We also recommend that the gutters and downpipes are cleaned out, the joints are checked and the alignment checked to ensure that the gutters fall towards the downpipes.

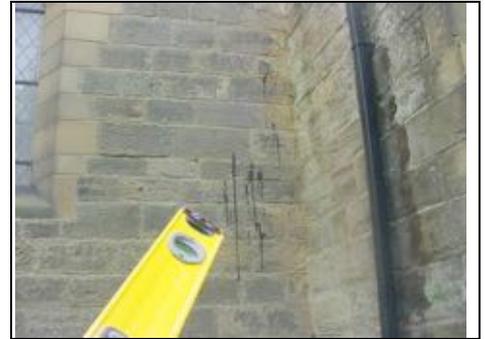
Tar on stonework to rear and downpipe leaking down wall

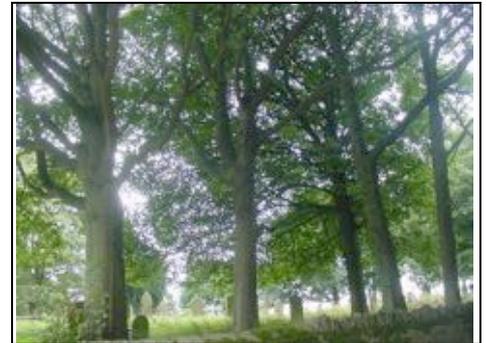
Trees in churchyard. Check they are regularly maintained otherwise they will cause problems to the boundary wall

ACTION REQUIRED: We recommend you have a meeting with the church prior to legally committing to purchase the property to find out what they plan to do with regard to tree management and maintenance. Ideally the church should offer you a 10 year plan of what is going to be carried out. Trees can have a considerable damaging effect on buildings if not maintained.

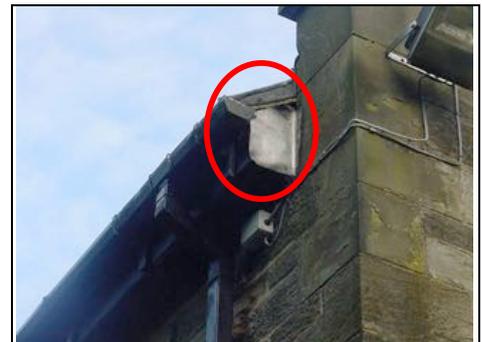
Flashband repair front right side

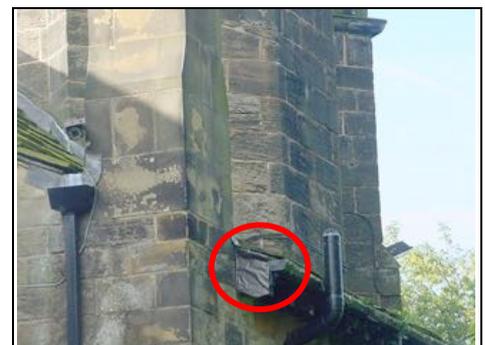
More Flashband repairs

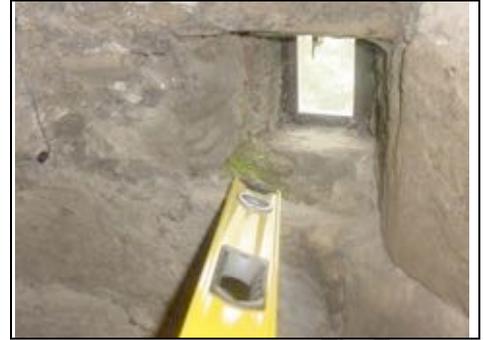
Dampness and moss coming through window

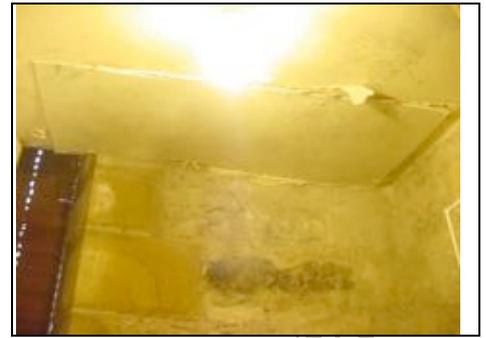
We note that some of the ceilings are damaged and are deteriorating, for example around the Nave and Chancel where they meet and also in some of the store room areas.

Damp in ceiling to store room off kitchen

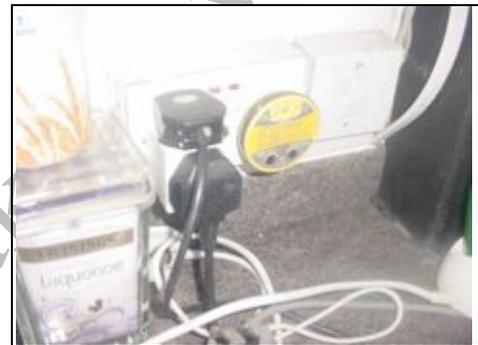
The electrics are dated and failed our earth test in the kitchen. We think the electrics are complex and have been built up over the years. The existing owners have built up a knowledge of these and you need to have a tour specifically noting down what light points refer to and the fuseboard refers to what if you do decide to purchase the property.

Earth test failed

ACTION REQUIRED: Replace fuseboard.

We recommend an Institution of Engineering and Technology (IET) test and report to be carried out by an NICEIC registered and approved electrical contractor or equivalent.

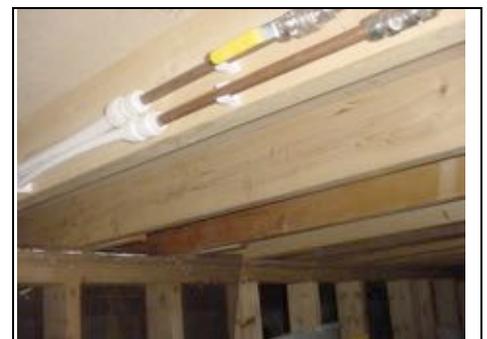
Mixture of plastic and copper piping

ACTION REQUIRED: Please see our comments in the Executive Summary.

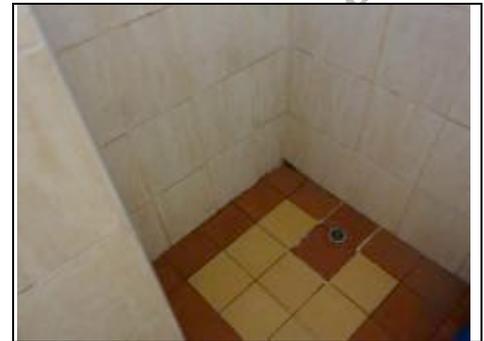
Black mould to tiles in shower room

ACTION REQUIRED: Please see our comments with regard to adding a large good quality humidity controlled extract fan.

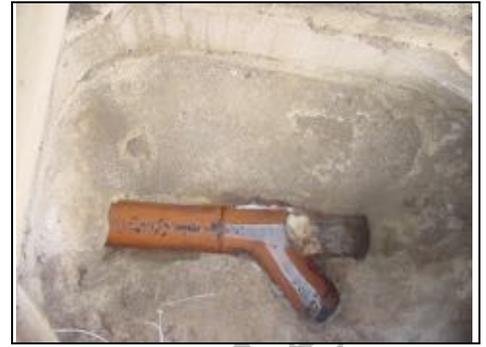
We duly lifted the cover and found it to be slightly blocked at the time of our inspection and it is a relatively shallow drain. From what we could see it is concrete built.

Manhole two located to north side/
east end
