# RESIDENTIAL BUILDING SURVEY

Horncastle  
Lincolnshire  
LN9 XXX

The property is Grade II Listed with a separate listing for the garden wall, as found in [BritishListedBuildings.co.uk](http://BritishListedBuildings.co.uk), English Heritage Building ID: XXXXX.

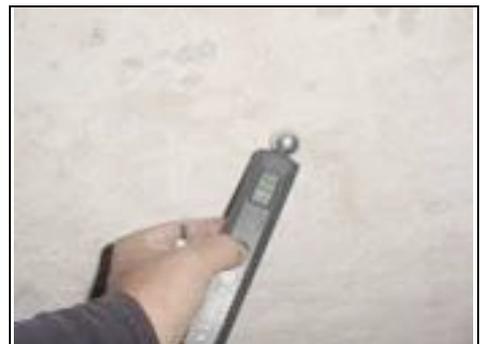
Damp meter reading

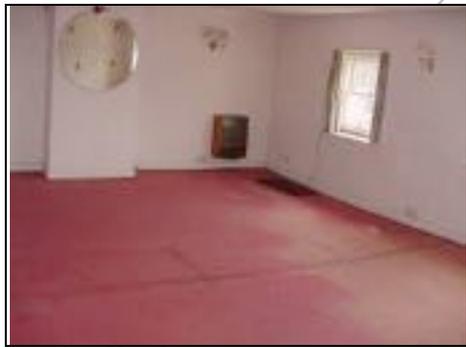
Right room

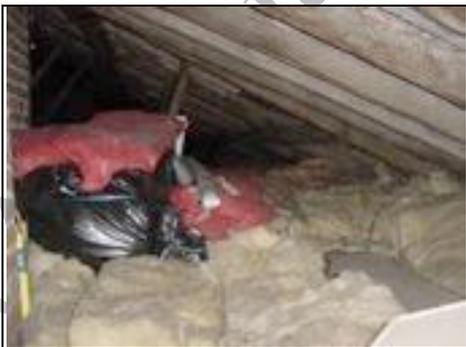
Rear left roof

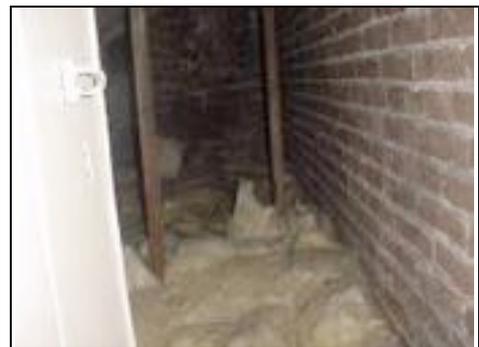
Rear right roof

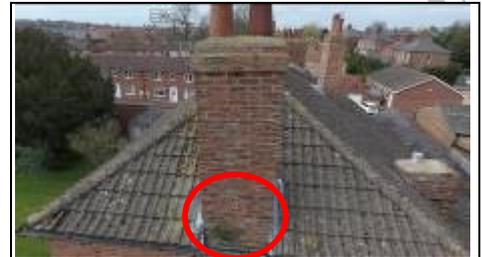
There is deterioration to the brickwork, for example we can see spalling has occurred and they have been repaired wrongly in cement mortar. Also, there have been poor quality repairs to the flashings.

Right chimney  
Poor quality repairs and plant growing

For example we are aware that during the course of the survey you mentioned the right chimney had been repaired. We can still see grass growing out of it and poor quality repairs and we are obtaining damp meter readings in this area so the work that has been carried out is poor and incomplete which unfortunately is typical of what we have seen to the other chimneys as well.

**ACTION REQUIRED:** All chimneys to be checked and overhauled including the flashings being checked and re-bedded as necessary. We believe each chimney needs looking at closely and good quality work carried out.

**ANTICIPATED COST:** £5,000 - £10,000, access scaffolding will be required; please obtain quotes. Some of the poor quality work cement mortar that has been carried out will have to be unpicked, etc, which unfortunately makes this job harder than if nothing at all had been done, not to mention the extra damage that has been caused.

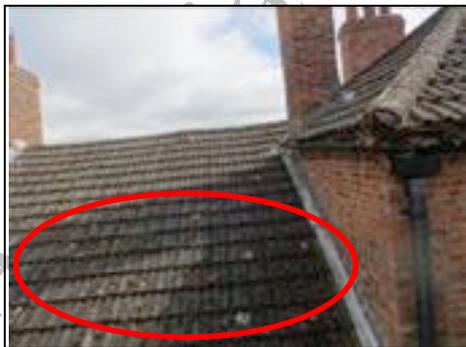
Spalling brickwork from chimney falling onto roof

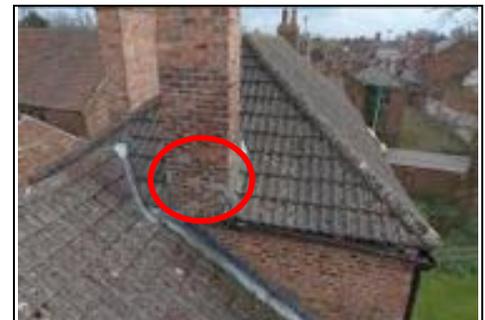
Poor quality cement repairs

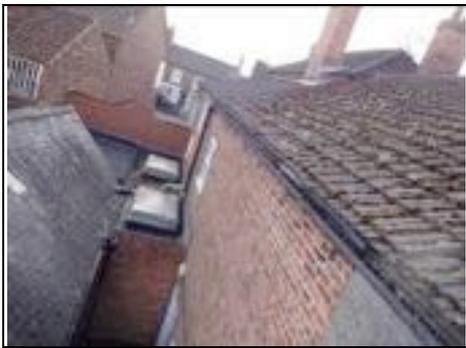
We particularly noted the left side of the roof where there seems to be problems of gauging the tiles correctly. This has resulted in a doubling up of tiles to the rear of the property and an out of alignment of the tiles to the front of the property. We believe that this has contributed to the dampness that can be seen inside to both the ceilings and the walls; further investigation needs to be carried out but fundamentally the roof gauging is the problem.

Doubling up of concrete tiles to rear

**ACTION REQUIRED:** Whilst the work to the chimneys and guttering is being carried out we would recommend that sections of the left hand roof are investigated to see the condition particularly to the perimeter of the roof (we would also recommend that you investigate the right side of the roof as well) so you can get to understand what is happening with the roof construction particularly on the left side.

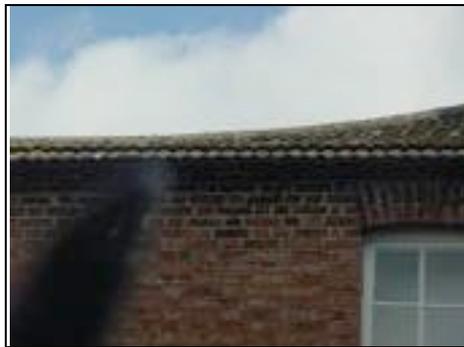
Badly gauged/tipping of concrete tiles/no tilting fillet to left side of front roof

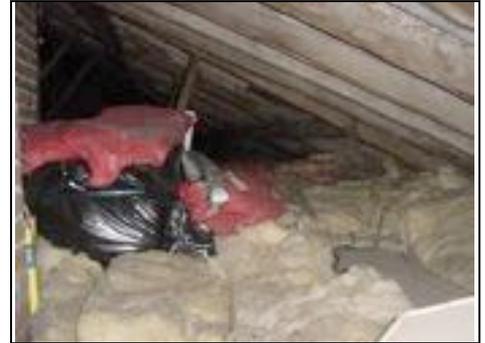
We can see the roof has been insulated. We believe it has been over-insulated for a property of this age, type and style and we cannot see any ventilation. Ultimately this will cause problems with the timbers in the roof leading to condensation possibly increasing woodworm activity etc (we would expect this roof to have some woodworm although from what we can see there is no significant woodworm damage and most woodworm is no longer active).

Over-insulated

**ACTION REQUIRED:** We would suggest that vents are added into the roof covering to reduce the chances of condensation, wet rot, dry rot and woodworm, etc. Also see our notes about adding lighting, ladders and boarding to the property to allow a closer investigation.

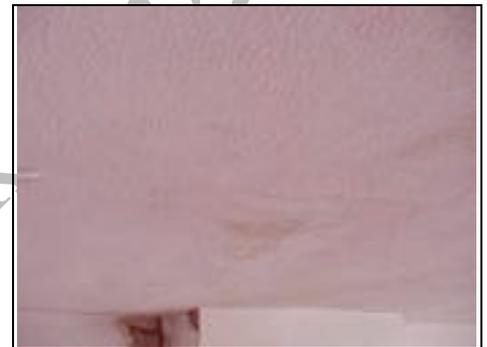
Top floor right bedroom modern textured paint ceiling indicating there has been problems in roof

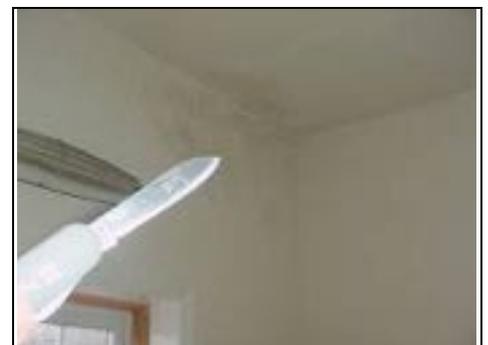
First floor far left bedroom dampness coming in underneath concrete tiled roof with tiles that are wrongly gauged.

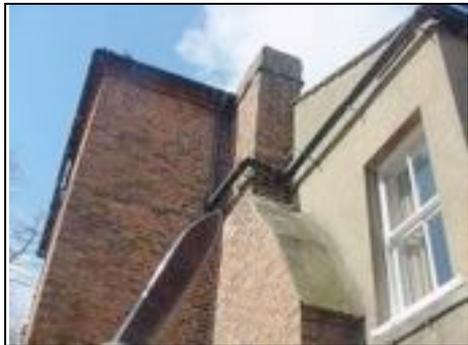
Awkward detailing from rainwater goods

**ACTION REQUIRED:** General maintenance and upgrading of the gutters and downpipes. You need to do a physical check on this property to ensure the rainwater is being captured by the gutters and downpipes and taken away. We would recommend that all the asbestos gutters are removed with the appropriate safety measures (it would be best to do an asbestos check on the whole property). Our insurance company requires us to advise we are not asbestos surveyors and advises us to recommend asbestos surveyors are instructed and that you have your own asbestos survey carried out.

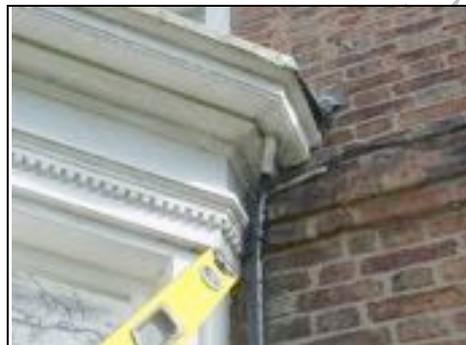
Ultra thin downpipe to front right bay window

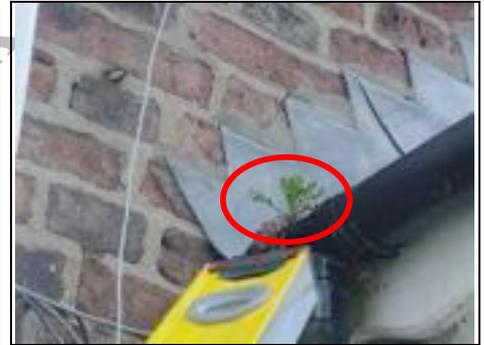
We also noted general lack of maintenance to the gutters and downpipes; there are areas of grass growing from the gutters and downpipes that were not secured properly or fixed properly.

Vegetation growing out of gutters and general lack of maintenance

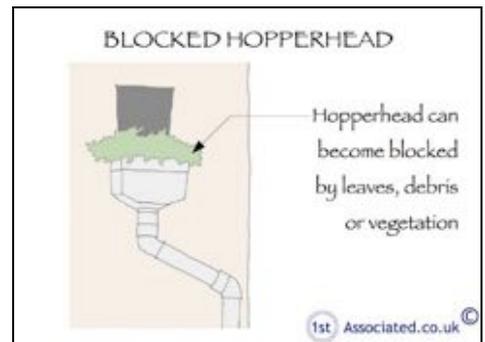
We also noted a number of hopperheads which we do not believe will be able to cope with heavy downfalls. Whilst these are standard sized hopperheads they are unlikely to be the size of a hopperhead that was originally on the property so we would be looking to make these larger once you have checked to see if they can cope or not.

Hopperhead easily become blocked with vegetation

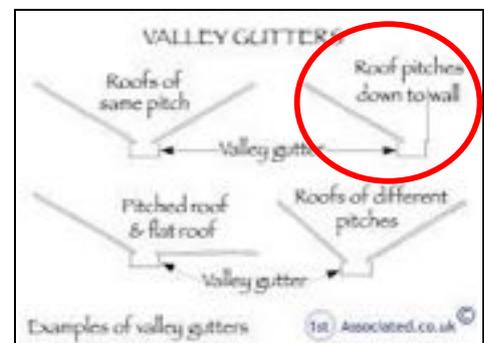
There are valley gutter problems to the garage/workshop area which we can see part has been repaired in lead but this needs double checking to ensure it is watertight.

Valley gutter problems

**ACTION REQUIRED:** This problem may well have been resolved although we were still getting some damp meter readings in this area. We would suggest that you speak to the owners and ask them when the roof work was carried out and whether there is any form of guarantee. We suggest that a dye water test on the flat roof and the valley gutter areas to check and test it is watertight (use a coloured water so you can establish if it is a new leak or not). If it is not watertight then patch repair and we would recommend that if the areas are replaced that an insulation cut to falls is used as well as a high performance felt.

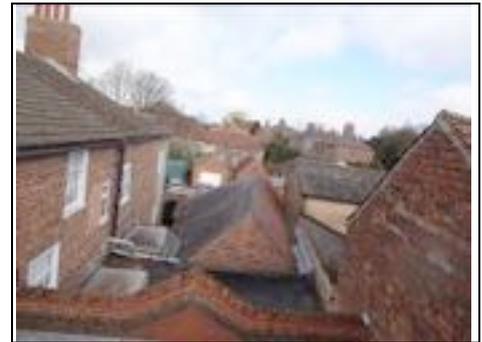
Considering the flat roofs in more detail, the flat roofs to the rear of the property are coming to the end of their natural life. Of course such roofs could be patch repaired forever and a day however the fundamental problem with this flat roof is that it is a flat flat roof and there is a fair amount of leaves, etc on the roof which is not helping matters. The basic problem we feel is the lack of a fall.

Flat roofs to rear

**ACTION REQUIRED:** We would recommend that insulation cut to falls is added to the roof using a high performance elastomeric felt.

**ANTICIPATED COST:** £5,000 - £10,000; please obtain quotations.

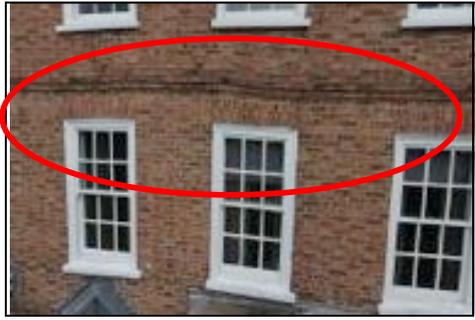
The front wall of the property is built predominantly in a Flemish bond brickwork which has been repointed in a cement mortar which unfortunately means that it retains more moisture than it should. This, together with the problems with the guttering has led to a damp external wall which we believe has led to movement.

Movement/twist in brick string course and associated brickwork  
~ Aerial View - 360 Photo ~

**ACTION REQUIRED:** The front wall needs to be tied into the floor structure. We would also recommend the checking of all joists where they meet the main wall as they are likely to be embedded timbers and there may well be some deterioration that has occurred that can be repaired which would help stabilise the property further. The property has been repointed in a cement mortar which does tend to indicate cracking and this is minimal on the external of the property around the window area from what we can see.

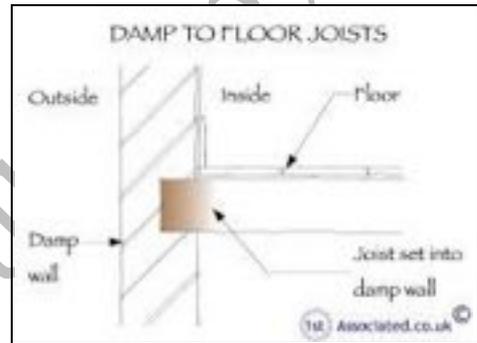
In addition to this the joists to the property go both side to side and front to back. These joists, as well as forming the floors, tie the property together. It is likely that they will have been embedded timbers. The condition of these needs to be checked and repairs and tying in to the walls carried out as necessary.

Embedded timbers

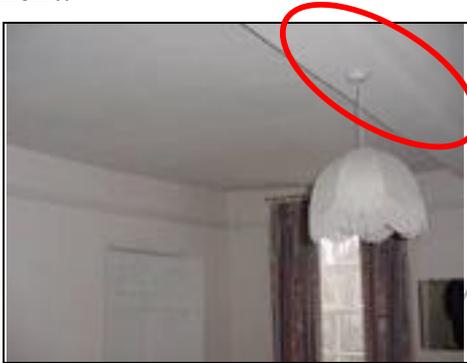
This means that the right side of the main property does not have any joists tying in on the front wall elevation which has resulted in the movement.

Spine beam running front to back meaning joists run side to side

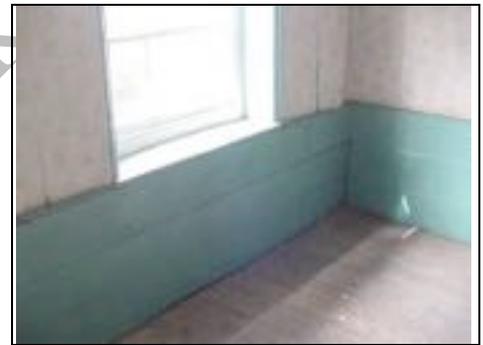
Top left room  
Floorboards running front to back therefore joists running side to side

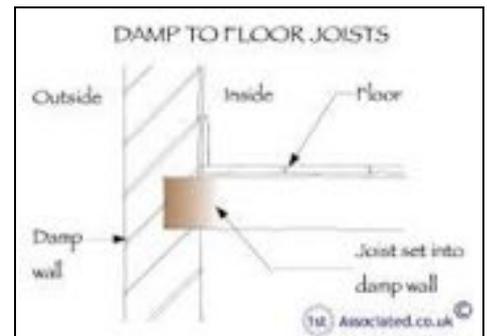
Embedded timbers

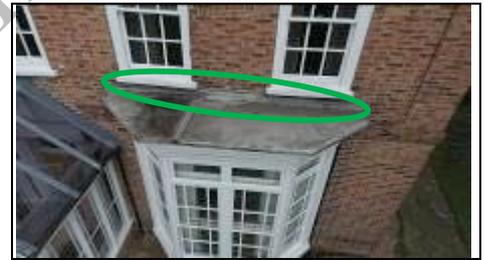
Bay window to right, beam will run under the windows where it meets the wall

**ACTION REQUIRED:** Open up the areas around the bay window and expose the beams/lintels and check the condition of the beam.

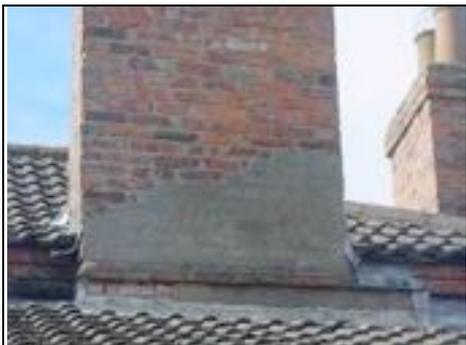
The walls have been repointed in a cement based mortar; this should be replaced with a lime based mortar as it is taking the face of the brickwork away as the mortar mix is too hard and ultimately will create what we term as spotted dog effect on the property. Unfortunately worse still, some of the bricks that have had the faces damaged have had a cement covering on them which should be removed and either the bricks replaced or taken out and reversed if suitable.

Cement repointing

**ACTION REQUIRED:** We would recommend you find a bricklayer who is experienced with older properties and lime mortar to carry out repointing of the brickwork over the summer months for the next few summers using a soft brush to remove any cement mortar. The only good thing generally with cement mortar repointing is that it does ultimately fall out on its own. Replacing the cement mortar with lime mortar will help the dampness problems that we are finding in the property which in turn are causing problems with the floor joists that are embedded into the walls.

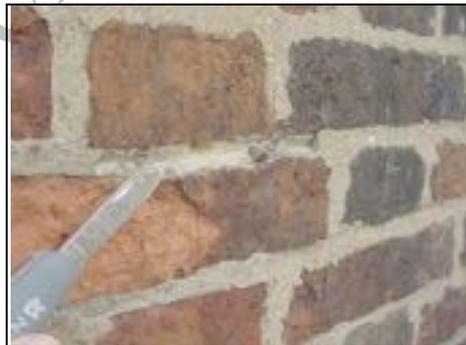
Cement mortar with lime underneath causing spalling to brickwork

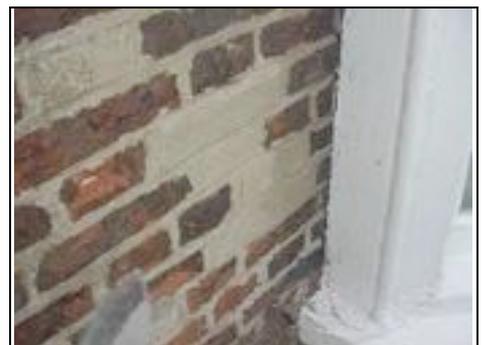
Cement repairs spotted dog effect to brickwork

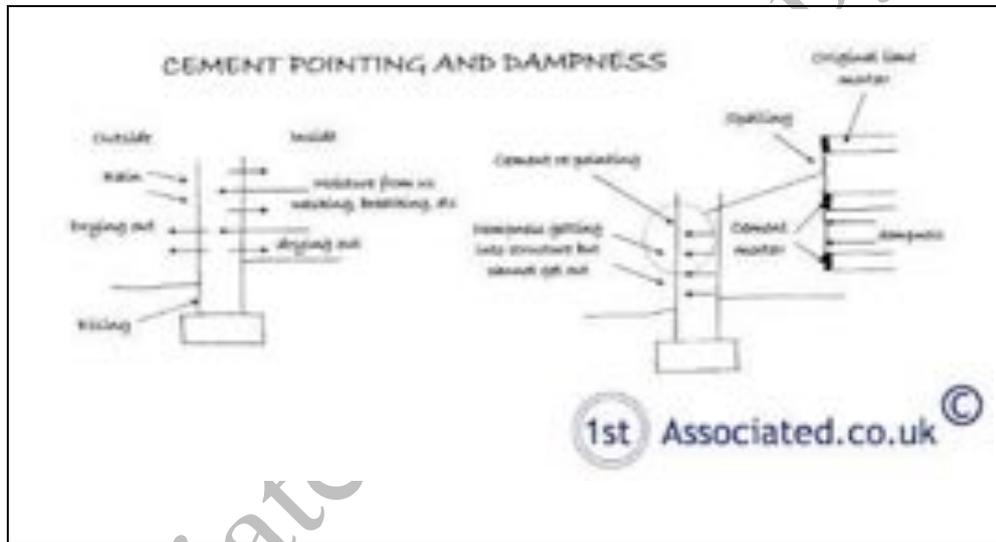
We would draw your attention to the cement mortar re-pointing that has been carried out on the exterior of the property that we feel is not appropriate to this building. Originally it will have been built with a lime-based mortar and this is what should be used for any re-pointing in the future.

The use of cement mortar causes deterioration to brickwork and does lead to the face of the bricks deteriorating, which in turn leads to dampness. This is a very important point.

**ANTICIPATED COST:** £10,000 - £15,000; please obtain quotations.

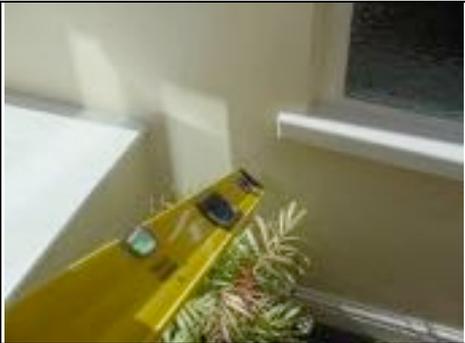
A modern plaster has been used to the rear of the property. The movement that we can see is around openings such as doors and windows, although it could be hiding major structural problems it does look to be typical of differential movement that we often find in properties such as this.

Crack internally to rear entrance lobby area

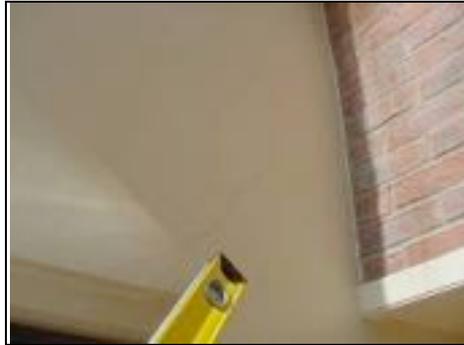
Crack to rear entrance lobby area

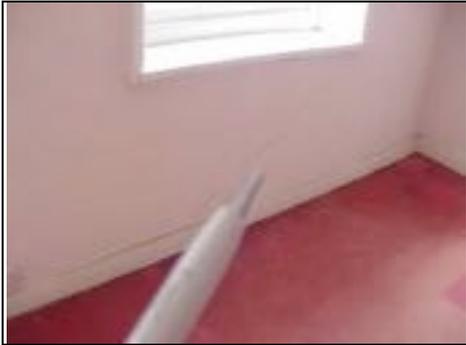
Top floor right room raking crack relating to movement to window below

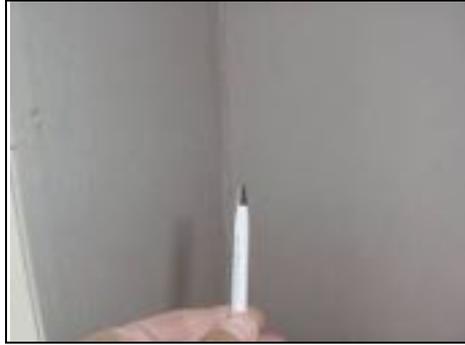
Top floor right bedroom. Crack between front wall and studwork.

**ACTION REQUIRED:** Whilst the repair work is being carried out to the floors and further investigation we would also recommend monitoring of the cracking.

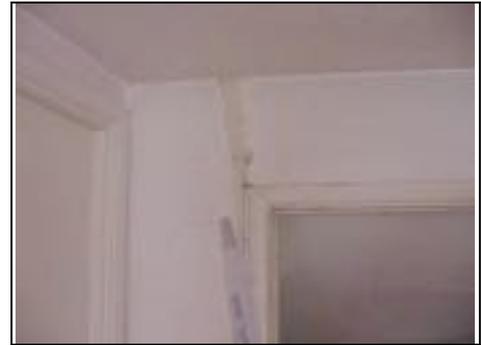
Top floor right bedroom cracking which we believe relates to movement to front wall and direction of joists discussed earlier

We believe this relates to the loss of a cross bracing from the front walls and possibly the heavier concrete tile roof contributing to the problem. We do feel this is historic and has now probably settled in place however we do feel also that monitoring should be carried out for a year whilst carrying out the repair work to the floors.

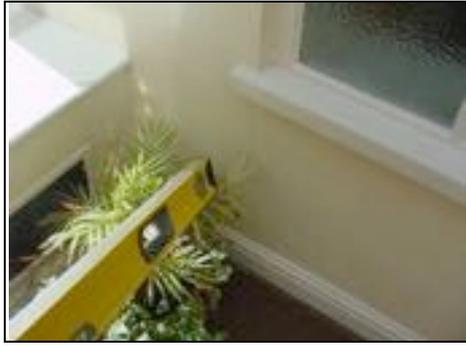
Crack in conservatory

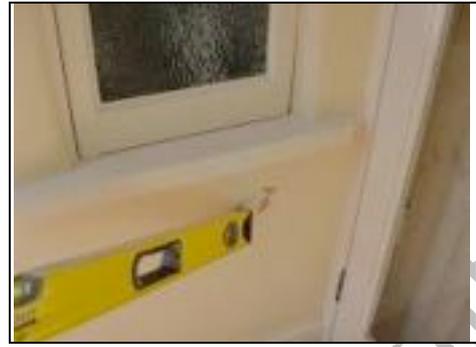
Modern plaster in conservatory not coping with seasonal movement in property

**ACTION REQUIRED:** We recommend this is replaced with a lime based plaster using a water based or lime paint onto the wall (or a micro-porous paint) all to the approval of the Listed Building/Conservation Officer.

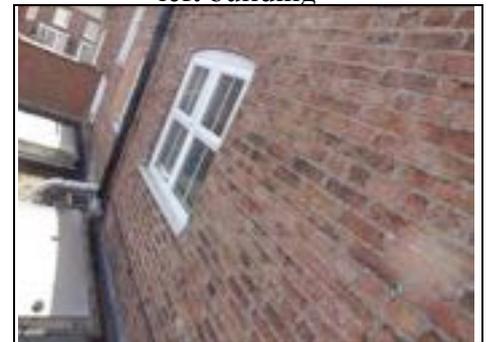
It was noted that some of the older windows have been repaired and replaced with modern windows. Our concern is that the older windows were of a structural quality timber whereas modern soft wood timbers do not have the same strength.

Plastic window to rear

**ACTION REQUIRED:** Approach the owners/Conservation Officer and ask whether consent was obtained and also if there is a specification available on the quality of windows. Unfortunately windows that do not have any structural strength will cause problems on the rear elevation in due course. When work on the windows is taking place you need to also check the lintels above the windows as these are likely to have been timber originally and may still be in place. You need to check and ensure that the window sill detail is appropriate for this age, type and style of building. For any windows that you do put in get agreement with the Conservation Officer.

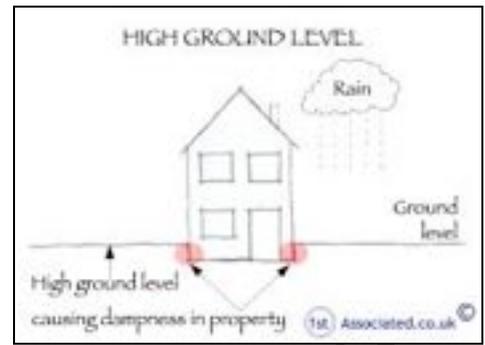
There are high ground levels around the property which should be reduced to all sides. To the rear of the property on the left side we can see specific problems with regard to the rear access to the property where modern cobbles seem to be discharging water against the building.

High ground level

**ACTION REQUIRED:** We would recommend that a French drain is added. There is a nearby manhole that the perforated drain can discharge into. This should help reduce the dampness further.

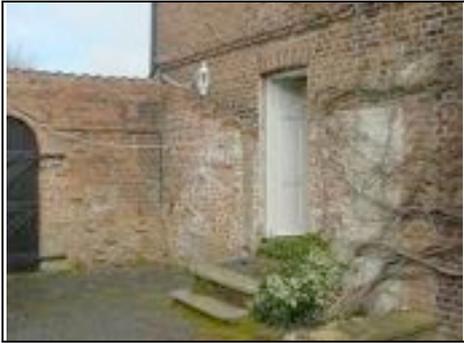
Change in ground level

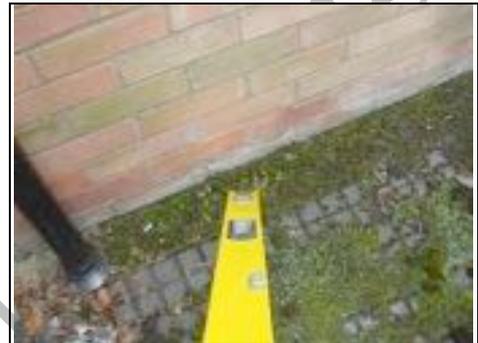
Water sitting on courtyard

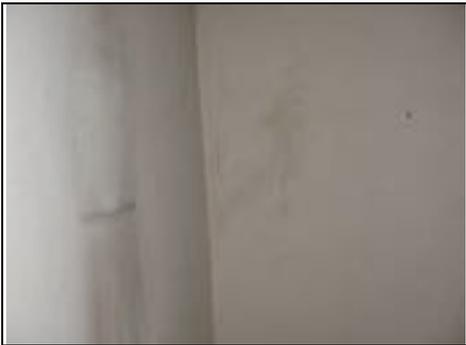
We also found areas of dampness to internal walls. As far as we can see there is no obvious reasons for this other than the high ground level that we have mentioned together with the courtyard not discharging water away and the slope on the site. There is an outside possibility that there are damaged pipes within the walls which we have come across before, however in the first instance we would carry out the work as mentioned in the high ground level section.

Dampness in front left bedroom of left building/annexe

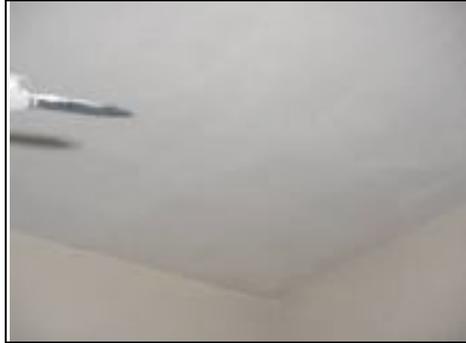
Damp to ceiling of left building/annexe

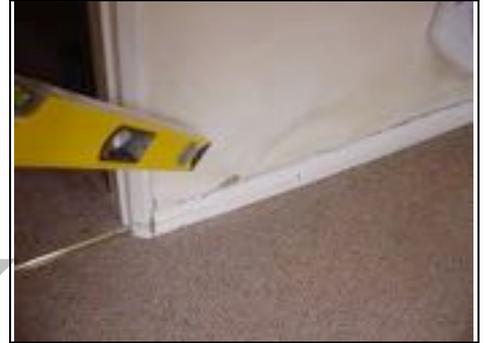
Dampness

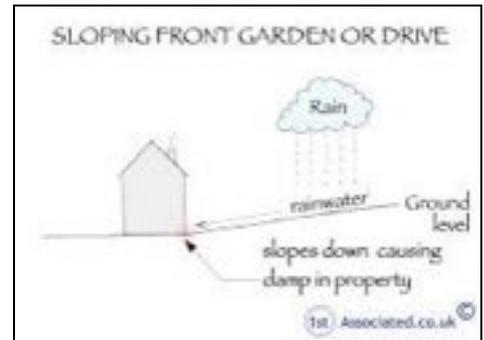
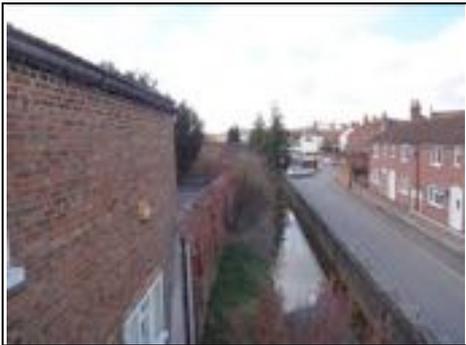
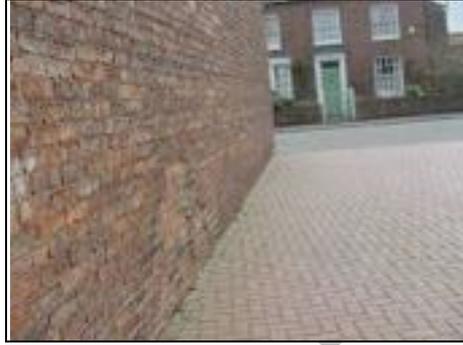
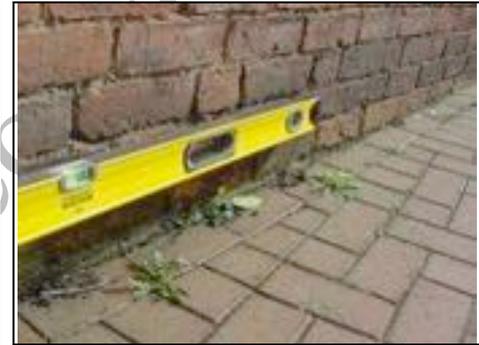
It may be deceptive but any property near a river or stream or culvert will be on a slope that slopes towards the river, stream or culvert. In this case we can see the driveway has a particular slope on it meaning that any water will discharge into the garage.

Stream to left

Slope towards garage

**ACTION REQUIRED:** We would comment that we do not believe that the existing narrow gully works and we would recommend the adding of a running gully or French drain. We would recommend it discharges to a new soakaway; please see our comments with regards to the rainwater gutters and downpipes.

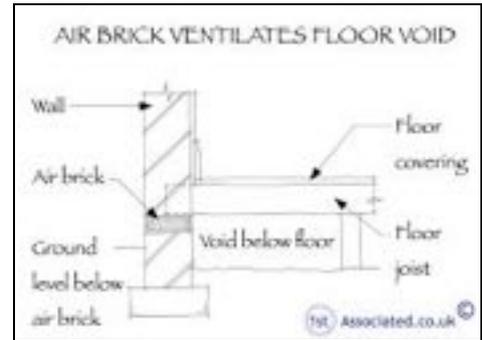
There is a suspended timber floor to the right side of property and joists and floorboards to left side of the property. There needs to be good airflow to both areas. Currently there is a high ground level which is blocking them.

Suspended timber floor

**ACTION REQUIRED:** We would recommend the high ground level is lowered and the grills are checked to ensure there is a good through flow of air under the floor. Open up a section of the floor to check the condition underneath it as again, we believe it is better to be safe than sorry.

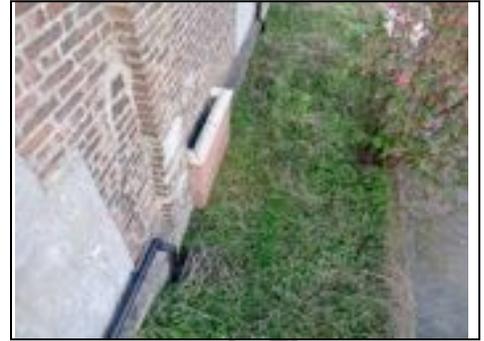
Window of cellar blocked to stop flooding

**ACTION REQUIRED:** With the changing weather patterns that we have where we tend to have more intense rainfall we believe it is likely that flooding will occur again. There is little that can be done about it, it is part of the bigger picture of our weather patterns and the drainage of the area.

The building has withstood floods in the past and we do believe older style buildings can cope with flooding far better than a modern construction however we also feel it is sensible that precautions should be taken such as the partial closure of the window to stop any medium rising of the nearby River Waring, we also feel that a sump pump should be added which discharges into a soakaway within the garden that we would recommend is positioned away from the river to the roadside of the garden which would then give the best chance of it functioning during medium sized flood emergencies.

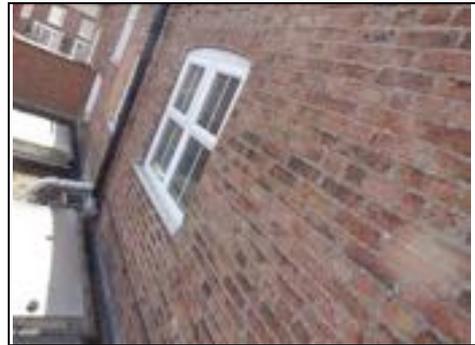
Plastic window to rear

You should be aware that any amendments that have been carried out without approval become your liability and your risk. This can be insured against by the owners but you do need to establish this before you purchase the property.

**ACTION REQUIRED:** We would recommend you visit the Conservation Officer/Listed Building Officer before you commit to purchase. Your legal advisor should write to them specifically requesting whether permissions have been obtained for the plastic windows being added to the rear of the property, for the roof windows to the flat roof, the repointing of the property in a cement mortar and the refurbishment of the left side of the building. We can provide a full list if you so require.

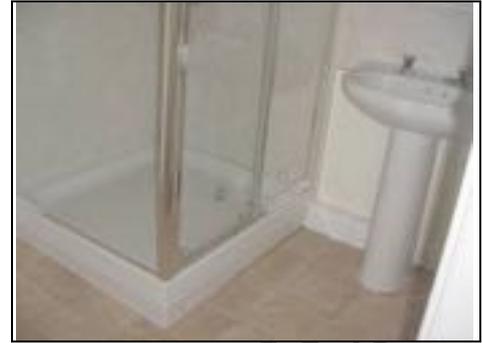
Sorry to reiterate however we do believe it is important with regards to the left side of the property to advise that a mixture of old and new materials have been used. We note that modern plaster has been used in a relatively small shower room. We do feel there is a chance of condensation occurring in this room.

Shower room rear left

**ACTION REQUIRED:** We would recommend large humidity controlled extract fans are added to the kitchen, the bathroom and any areas that are used for drying clothes internally during winter months (we would assume that clothes will be dried externally during the warmer months). By large extract fans we mean 150mm. It is likely that replastering work will ultimately be needed in this area.

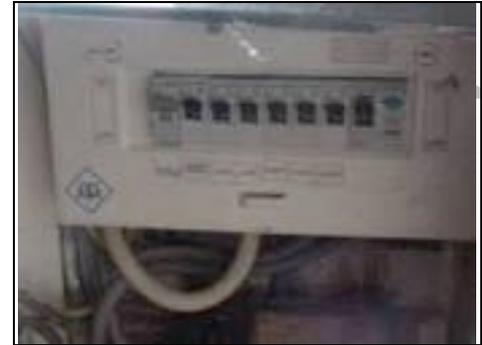
The electrics are 1970's to 1990's in the right hand building, they looked to be relatively new in the left building therefore certificates required.

Dated electrics

**ACTION REQUIRED:** We recommend an Institution of Engineering and Technology (IET) test and report to be carried out by an NICEIC registered and approved electrical contractor or equivalent.

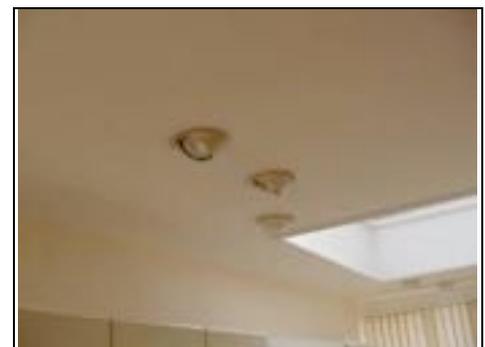
The property has 1970's electric lights to the ceiling. In some instances these can cause problems as the heat given off has in some cases lead to outbreaks of fire; these tend to be in the older type of ceiling lights and we recommend that where ceiling lights are used that the rear of the light is not covered; this is particularly the case in rooms with a loft space above it where stored items are placed in it.

1970's lighting

**ACTION REQUIRED:** We recommend replacing older style ceiling lights.

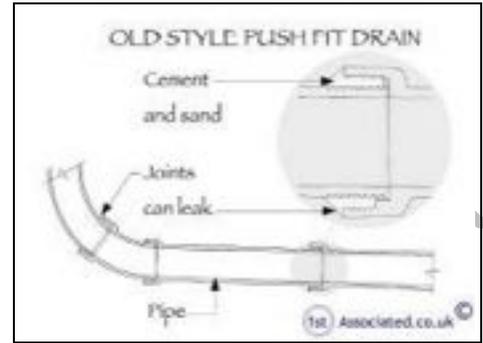
In older properties, such as this, drainage was often push fitted together rather than bonded together which means that they may leak over the years.

Push fit drain

**ACTION REQUIRED:** Whilst we ran the tap for 15 minutes without any build up or blockages the only way to be 100% certain of the condition of the drains is to have a closed circuit TV camera report.

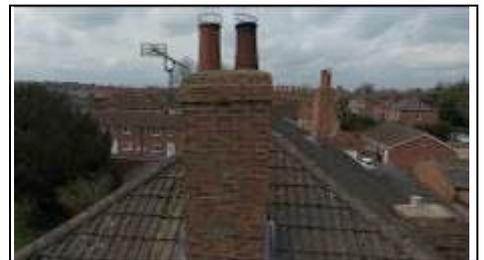
Right Chimney

This chimney is brick finished with a lead flashing and two chimney pots. From what we could see from ground level it looked in below average condition considering its age, type and style.

We noted an aerial attached to the chimney which we are not keen on as it cuts into the brickwork rather like a cheese wire cutting into cheese.

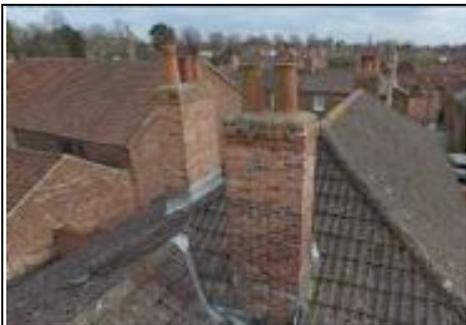
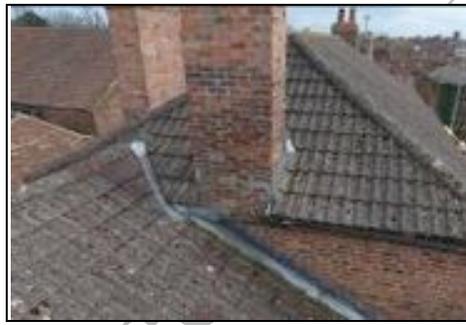
Chimney Two

This chimney is brick finished with a lead flashing and two chimney pots. From what we could see from ground level it looked in below average condition considering its age, type and style.

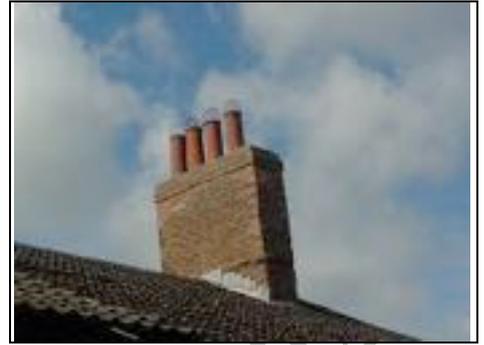
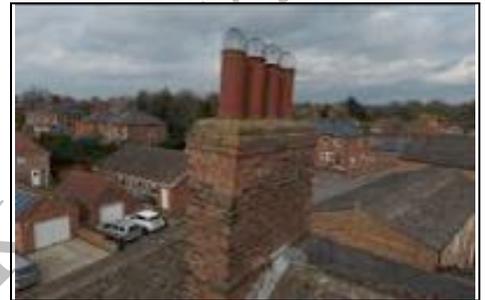
Chimney Three

This chimney is brick finished with a lead flashing and four chimney pots. From what we could see from ground level it looked in below average condition considering its age, type and style.

**ACTION REQUIRED:** Please see our comments in the Executive Summary.

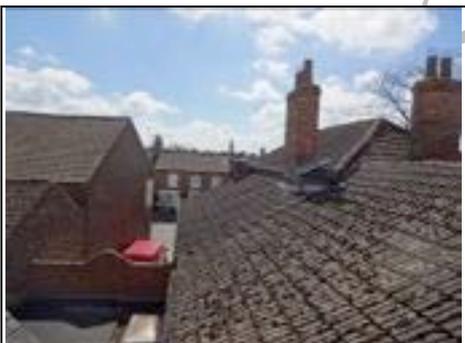
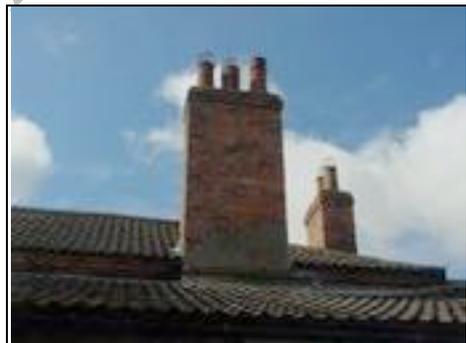
Chimney Four

This chimney is brick finished with a lead flashing and three chimney pots. From what we could see from ground level it looked in poor condition considering its age, type and style.

**ACTION REQUIRED:** Please see our comments in the Executive Summary.

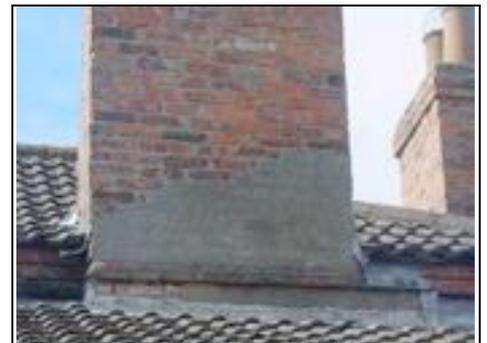
Cement repointing

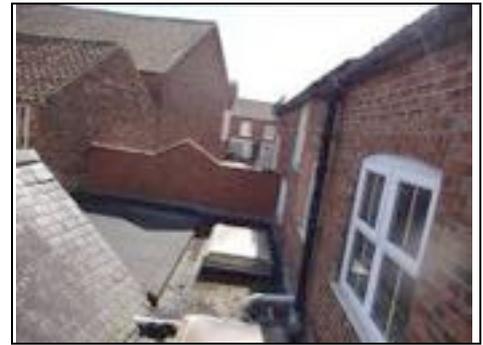
In this case there is a parapet wall to the right built in a stretcher bond brickwork with a coping stone which looks relatively new. You need to check and confirm whether listed building consent has been obtained for this parapet wall.

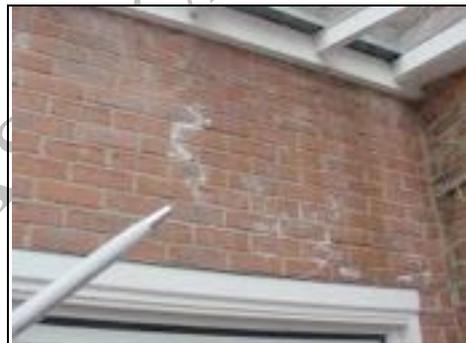
Efflorescence below parapet wall indicating it is allowing dampness in

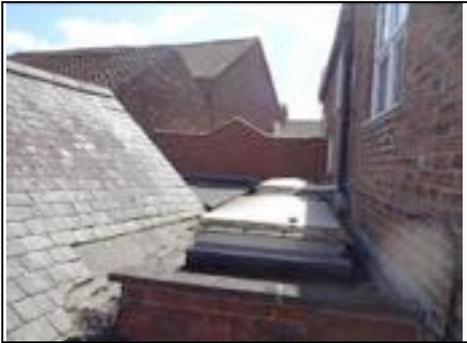
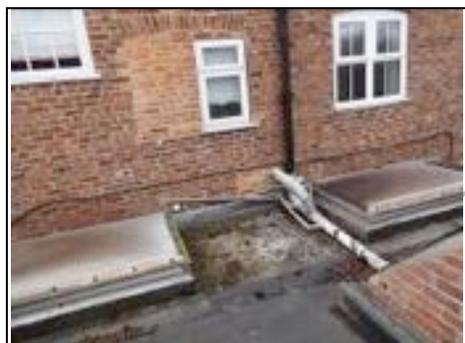
The property has two roof windows to the rear flat roof. These are an older style purpose made roof window probably from the early 1960's to 1980's which looked in below average condition. We could see the flashing around them and we could see in this instance they have been repaired. We believe this sort of domed roof window is the better type as it does not allow water to sit on it however it is probably coming to the end of its useful life.

Roof windows to rear flat roof

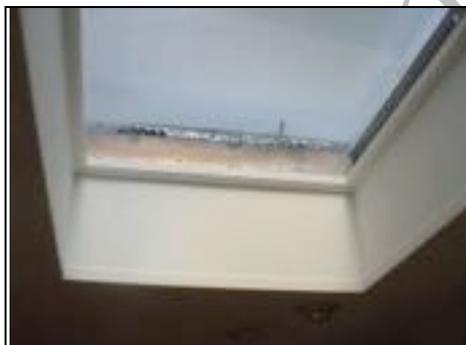
Deterioration to roof windows

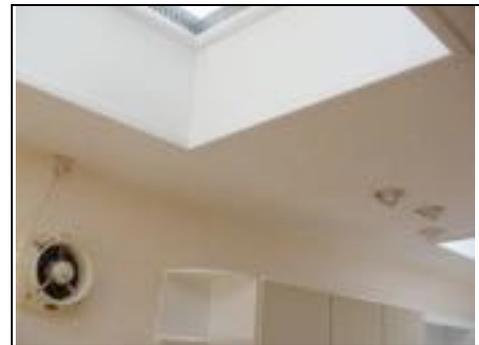
Roof windows in kitchen

It seems inevitable with roof windows that they will sooner or later leak. If this doesn't occur then they seem prone to condensation. Keep a cloth handy!

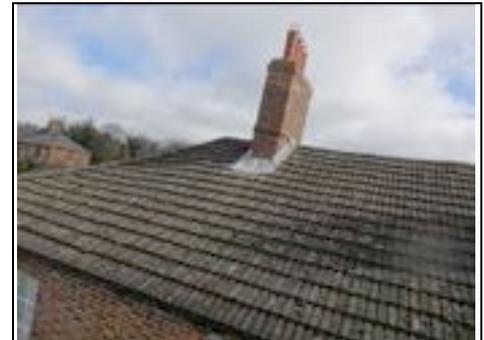
Main roof

From ground level, this looks in average condition considering the roofs age type and style however from closer inspection we can see there are problems to the left side of the roof.

A heavier concrete tile has replaced the original roof covering and therefore there should be additional roof support which there does not look to have been and as such the roof has probably put pressure onto the walls which in turn relates back to the movement that we talked about. On closer inspection the left roof seems to have been poorly re-roofed; please see our comments in the Executive Summary.

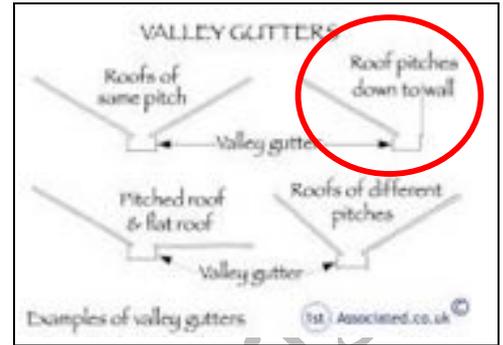
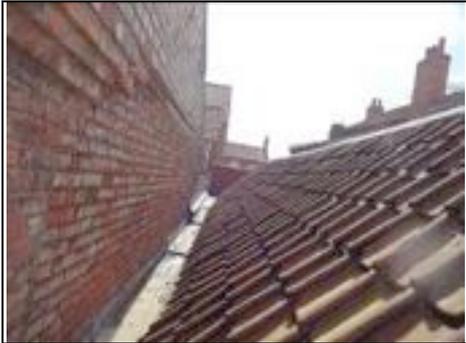
This property has a few valley gutters. Valley gutters are formed where two roofs meet or a roof and a wall meet, they are generally problematic.

Valley gutter to rear of pantile roof

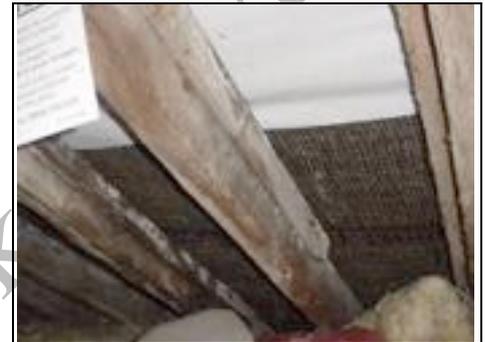
Breathable protective underlayer indicating modern alterations as well as hessian felt

We also found a breathable protective underlayer indicating that modern alterations have taken place. This type of material has generally been used since around 2002.

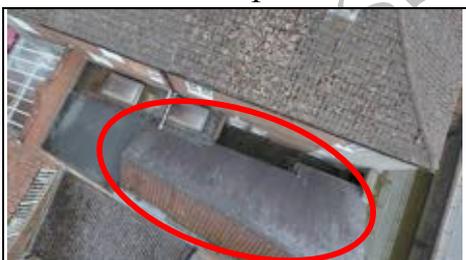
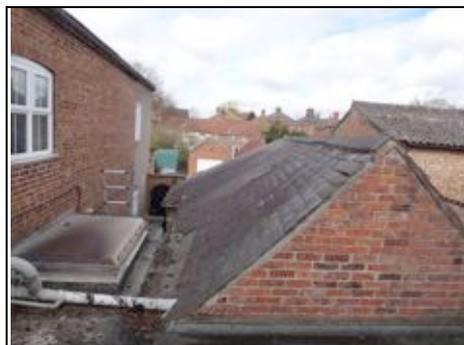
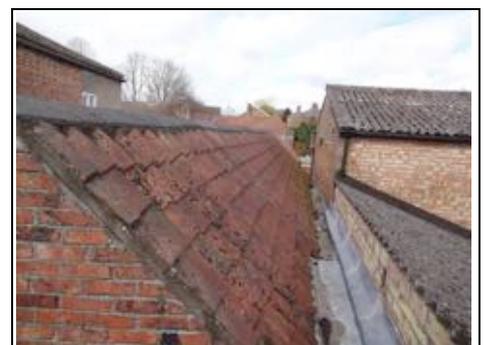
The garage roof is slate one side and tiled to the other. The slate roof has seen better days and we can see areas where tingles have been added. There are leaks visible internally to the gutter area and the whole of the garage is generally in a poor condition, depending on what you intend to keep in this area will dictate the quality of repair work.

Aerial photo of garage roof

Garage slate roof  
Aerial view – 360 photo

Garage tiled roof  
Aerial view – 360 photo

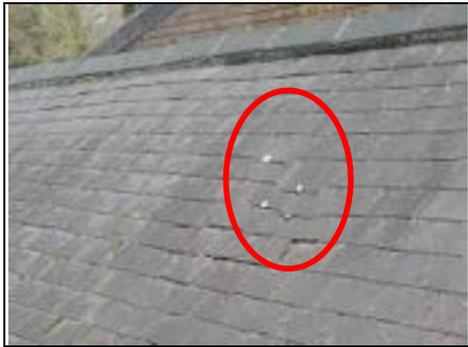
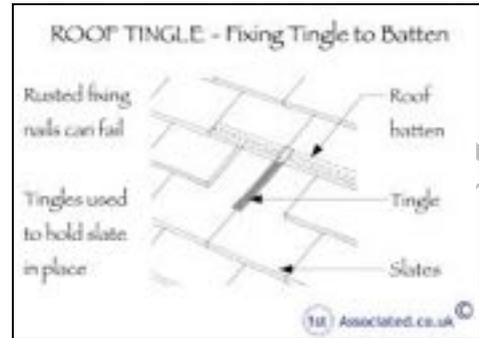
Tingles to slates on garage roof

Tingles

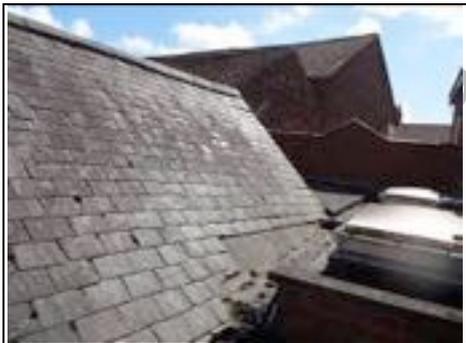
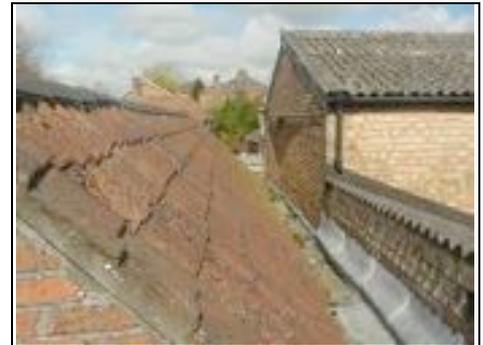
The verge also needs repair work as this will be letting in rain. We believe the main focus should be on the house. We spoke to the antiques/bric a brac store next door and they advised that they have no particular problems coming from this property and it is the garage that directly abuts them. The main problem to the garage area seems to be the valley gutter; please see our earlier comments.

Garage slate roof

Garage tiled roof

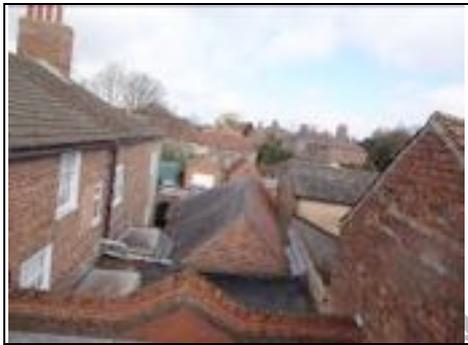
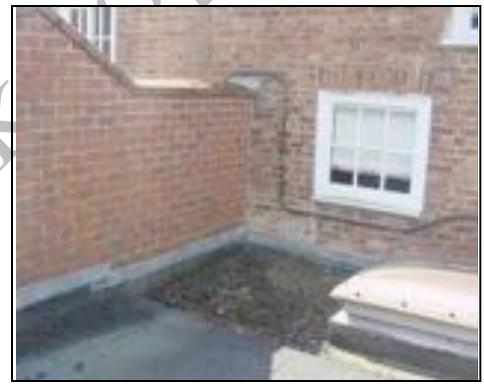
This is a flat flat roof clad in felt which looked in average condition for its age, we believe it is from the 1960s's/1970's. The main problem is it is a flat flat roof.

Flat roofs to rear

Flat roof

**ACTION REQUIRED:** Please see our comments in the Executive Summary.

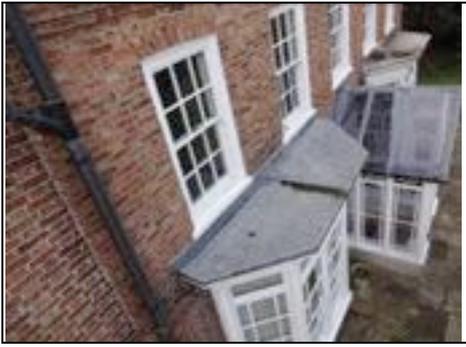
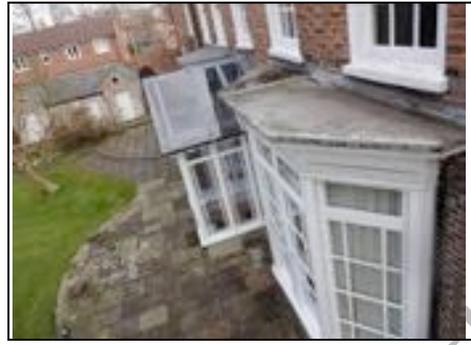
These are a flat roof clad in lead which looked in average condition.

Front left lead bay window roof

Right bay window

**ACTION REQUIRED:** Please see our comments in the Executive Summary.

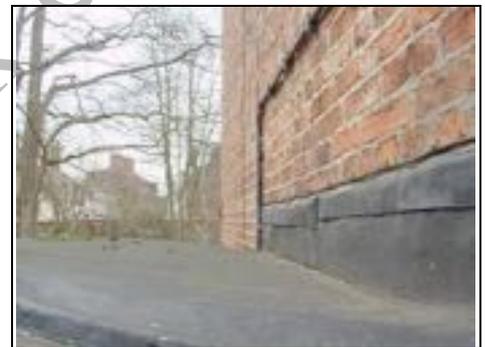
This is a flat roof clad in older style felt which looked in average condition. This may have originally been lead; further investigation needs to be carried out. We do believe it is nice to have lead flat roofs where historically correct. Again you will need guidance from the Listed Building/Conservation Officer.

Roof to circular bay on right side

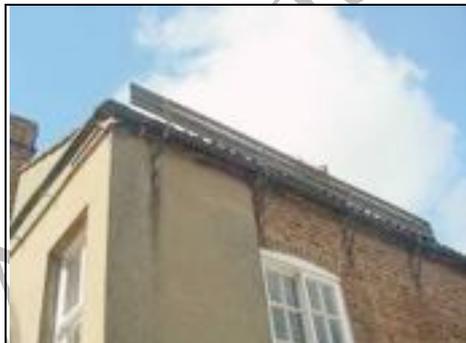
We were pleased to see this roof had a lead flashing where it meets the main building. Your legal advisor needs to check and confirm this has planning permission along with the new looking parapet wall that we have previously mentioned. There are guards to stop any roof tiles that come off hitting the conservatory below.

Guard to stop roof tiles hitting conservatory below

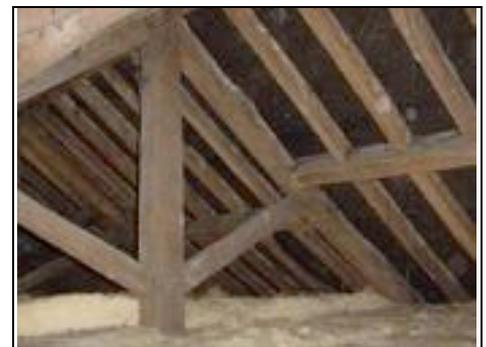
This type of roof structure has what is known as a kingpost roof. Without the original design details we cannot categorically confirm that there are no defects; however it is in line with what we typically see. We can see more dampness to this roof than we normally see and some of the timbers are thinner than we would expect particularly bearing in mind there is not a heavier concrete tile roof on the property. We are also concerned with regard to the insulation in the roof as we believe it may be over-insulating the roof and causing condensation.

King post roof to left

**ACTION REQUIRED:** We recommend the roof is vented. We would recommend the roof is fully lit and boarded and then we would be happy to view the roof. The only way to be 100 per cent certain is to have the roof cleared and checked.

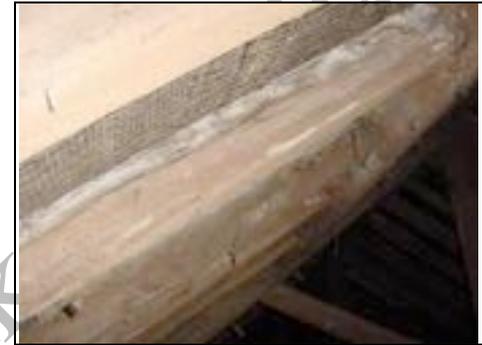
Our examination was limited by the general configuration of the roof and the insulation. What we could see was generally found to be in below average condition for its age, type and style. It is, however, feasible that there are problems in the roof that are hidden.

Woodworm

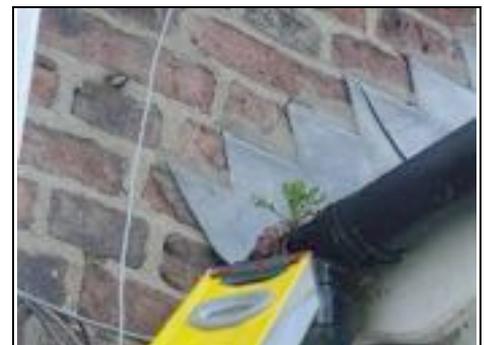
We noted that the property has a mixture of cast iron gutters and downpipes and modern replacement plastic gutters and downpipes. Where these two materials are mixed there are often problems where they join and also in the falls to the outlets.

Vegetation growing out of gutters and general lack of maintenance

We also recommend that the gutters and downpipes are cleaned out, the joints are checked and the alignment checked to ensure that the gutters fall towards the downpipes.

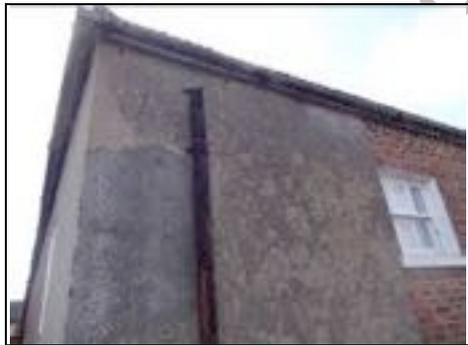
The property has a soil and vent pipe to the rear of the property and we believe a disused soil and vent pipe to the rear right corner. There are a mass of pipes to the rear of the property which is usual in any old property where there has been alterations and additions over the years. Originally of course it would not have had bathrooms and w.c.'s inside.

Believed to be disused soil and vent pipe to rear right corner

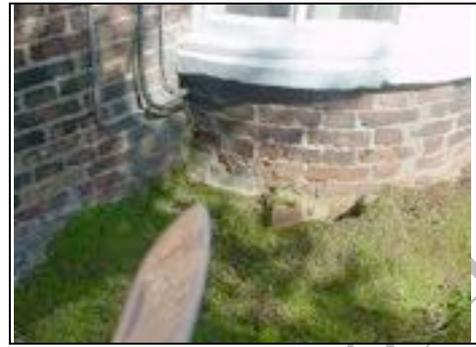
Cement repairs to base of semi-circular window

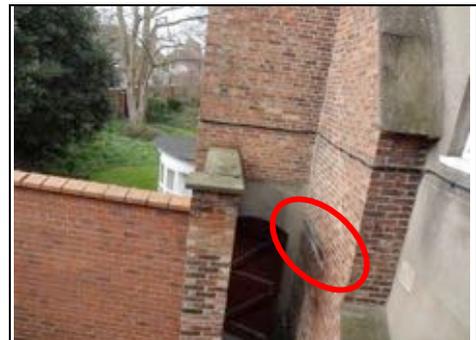
Before the 19th Century, the practice of building timbers into external walls was almost universal. These were known as bonding timbers. They are of course prone to rot as solid walls allow dampness through. Unfortunately, without opening up the structure, we are unable to confirm if this is the case.

We can visibly see one timber to the right side of the property, there may be more within the property.

Bonding timber to right side of property

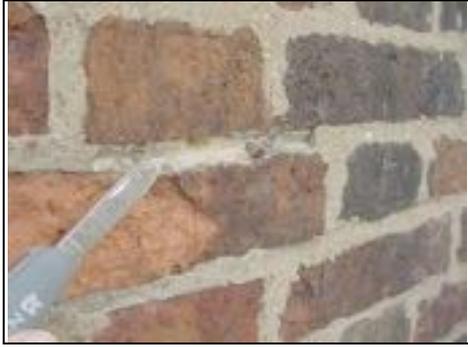
Repointing in cement

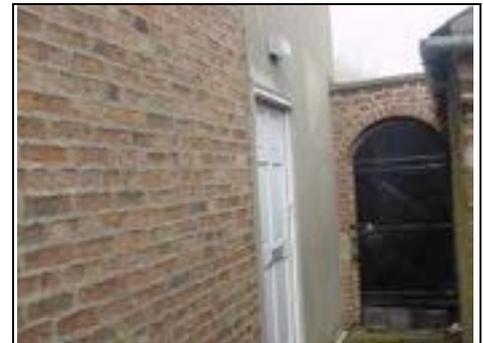
We are always wary when we see rendered properties as it usually means they have been rendered for a particular reason such as hiding problematic areas, perhaps damaged and deteriorating brickwork or perhaps movement as we can see movement to the rear right conservatory entrance area.

Render to rear left corner
