# RESIDENTIAL BUILDING SURVEY

Horncastle  
Lincolnshire  
LN9 XXX

The property is Grade II Listed with a separate listing for the garden wall, as found in [BritishListedBuildings.co.uk](http://BritishListedBuildings.co.uk), English Heritage Building ID: XXXXX.

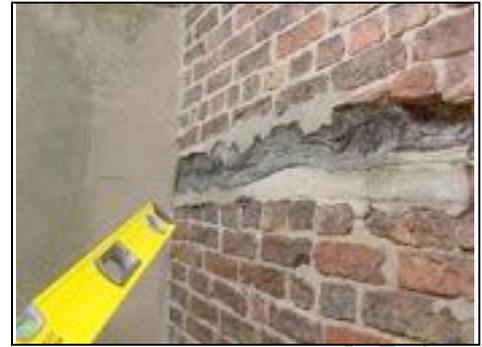
We can an area where there is a timber beam. This may indicate there are other timbers within the property.

Timber

**ACTION REQUIRED:** We would suggest that opening up is carried out in this area and also to parts of the render to see what is beneath it.

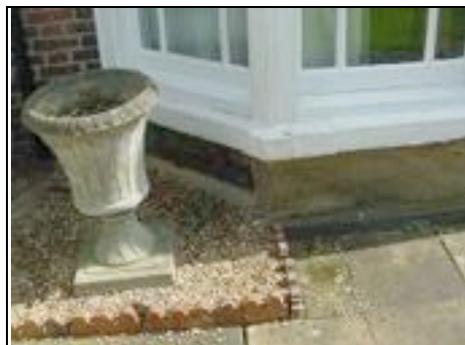
Deterioration to stonework under bay window

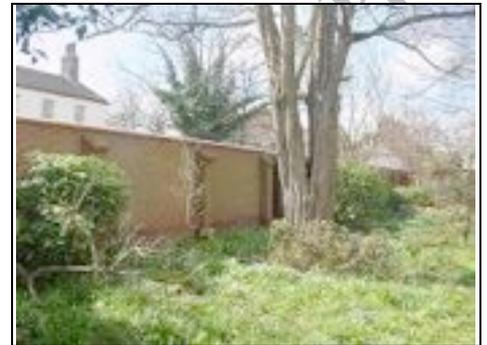
There are trees within what we would term as influencing distance but you do need to speak to your insurance company as they may have a different interpretation for insurance reasons. It is likely the trees have tree preservation orders on them so it is limited what you can do.

The tree is located in front garden

**ACTION REQUIRED:** We would recommend an arboriculturalist (not a tree surgeon) is asked to view the property and give a ten year plan for maintenance. It should also be remembered that the trees are close in some instances to the garden wall that is also separately listed.

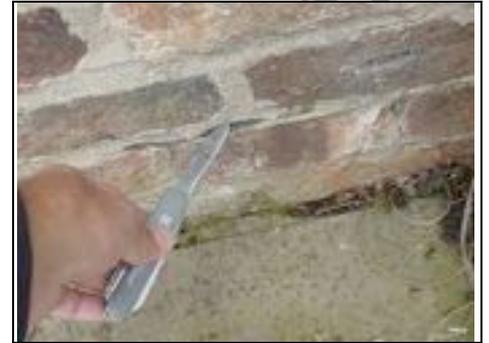
In properties of this age it is unlikely that a damp proof course would have been built in originally however, often they have had damp proof courses added at a later date. In this case we were surprised to see a damp proof course on the left side, although only visible in some areas so it has probably been inserted at a much later date. It is considerable work to insert a plastic damp proof course like this so more needs to be known about it.

Damp proof course

**ACTION REQUIRED:** Your legal Advisor to ask in writing if the existing owner added the damp proof course and if so whether they had permission to add the damp proof course.

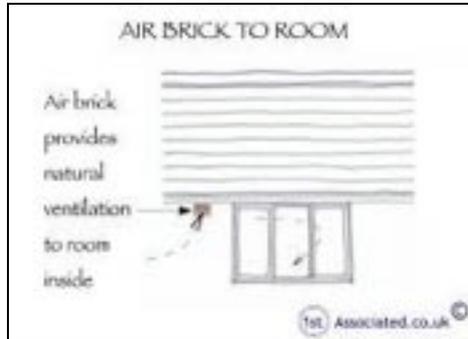
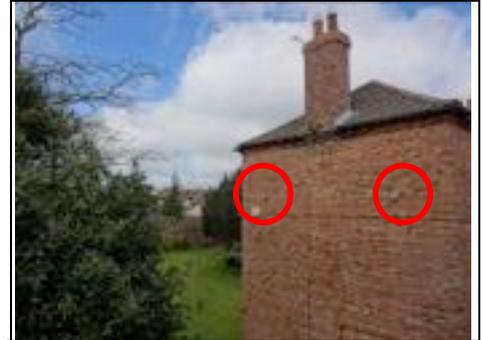
High level air bricks are normally for air circulation but in this case these air bricks look to be into the top floor. They could have been added to help vent the floor and reduce wet rot, dry rot and woodworm.

High level airbrick

High level airbricks

**ACTION REQUIRED:** Again we would recommend your legal advisor ask in writing as to why these have been inserted on the right hand elevation as it is relatively unusual.

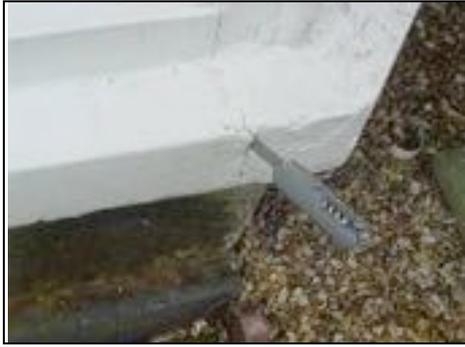
Very hard filler in some instances

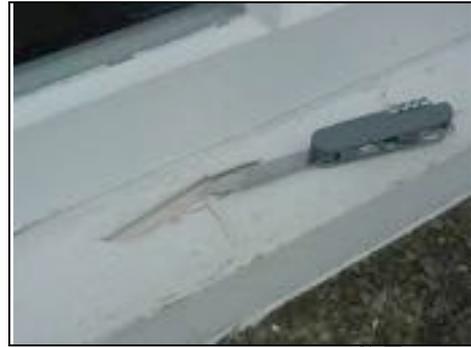
The property has single glazed timber sliding sash windows with and without sill details, older windows tend to have minimum sills. The windows are generally in average to poor condition with some wet rot, cracking and flaking paintwork.

Cracking and there is general flaking of paintwork

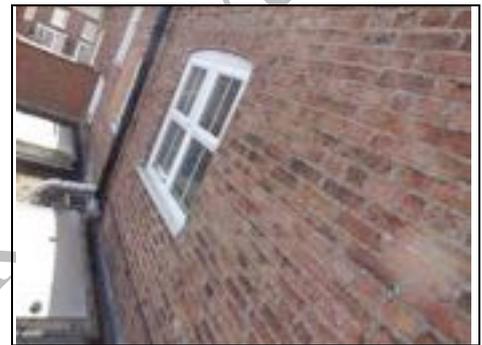
To the rear the property has plastic double glazed windows. It is unlikely these were given permission. From what we understand from your discussions with the owners they will replace them. We believe it is probably best if you have a monetary discount on the property and that you then take over replacement of all windows, etc.

Plastic window to rear

**ACTION REQUIRED:** We would recommend a monetary discount on the property and also discussions with the Listed Building/Conservation Officer as to what they are and are not happy with on the property generally with regard to modern alterations.

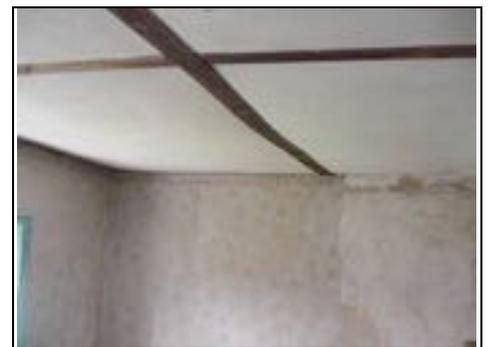
From our visual inspection of the ceilings and our general knowledge of this age and type of construction we believe that the ceilings are likely to be lath and plaster with a modern plaster to the new parts. To the top floor there is some proprietary boarding with a trim over it. There are instances where there is an asbestos element to proprietary boarding.

Proprietary boarding

**ACTION REQUIRED:** Our insurance company requires us to advise we are not asbestos surveyors and advises us to recommend asbestos surveyors are instructed and that you have your own asbestos survey carried out.

An asbestos report is required on the property as a whole.

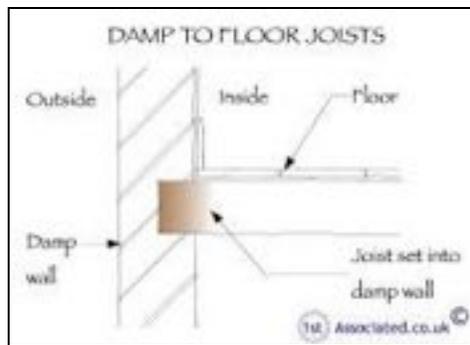
We have assumed that the first floor construction is joist and floorboards with embedded timbers, as this is typical in this age of property. We also noted spine beams giving support. The joists run both side to side (right side) and front to back (left side).

Embedded timbers

**ACTION REQUIRED:** Open up the floors to check the condition of the timbers where they are bedded into the walls and also the condition of the timbers generally.

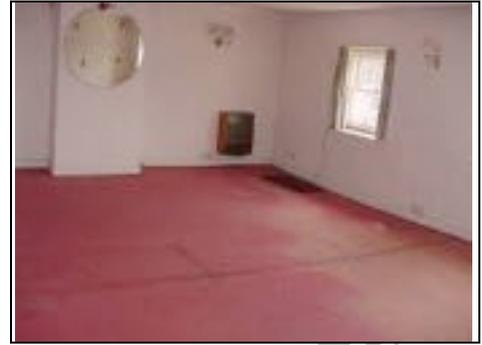
Dip in floor of top floor right room  
(all directions given as you face the front of the property)

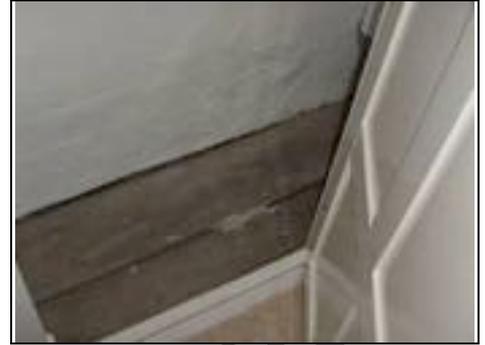
Floorboards in cupboards indicating joists run from front to back on first floor of left side of building

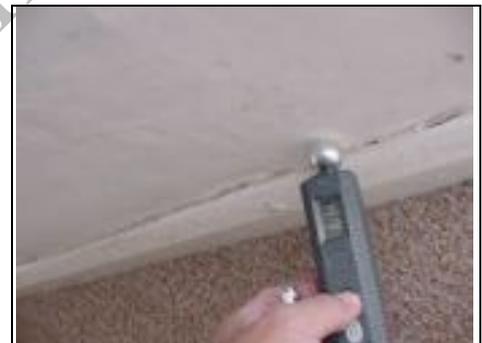
A visual inspection and tests with a moisture meter have been taken to the perimeter walls. In this particular case we have found significant rising damp. Interestingly there was a fair amount on internal walls which needs some further investigation.

High readings of rising damp

**ACTION REQUIRED:** Please see the Executive Summary.

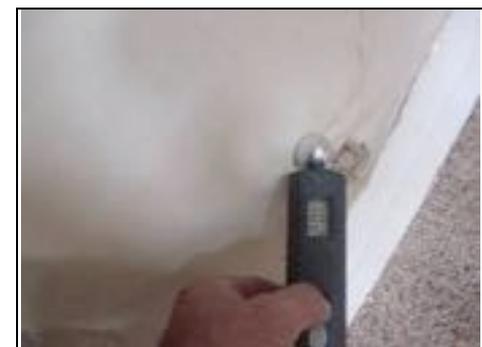
Rising damp

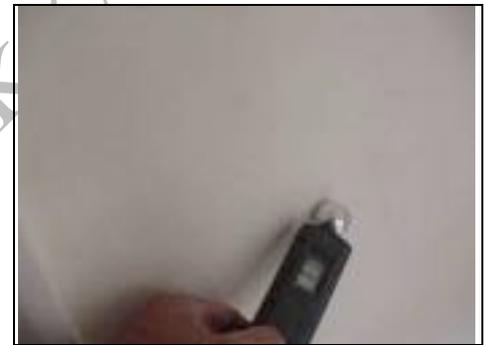
We used a resistance meter on the external walls. We found it to be in line with what we would expect for an unoccupied older property.

Testing for lateral dampness

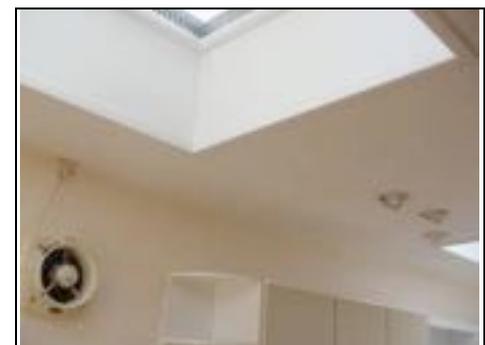
At the time of the inspection there were no significant signs of condensation however the property has been uninhabited. We did note that there were roof windows in the kitchen which will tend to get condensation. We were also pleased to see a large extract fan in the kitchen of the type which we like rather than the smaller extract fans.

Old style extract fan in kitchen

**ACTION REQUIRED:** We would recommend large good quality humidity controlled extract fans be added to kitchens, bathrooms and any rooms where you intend to dry clothes.

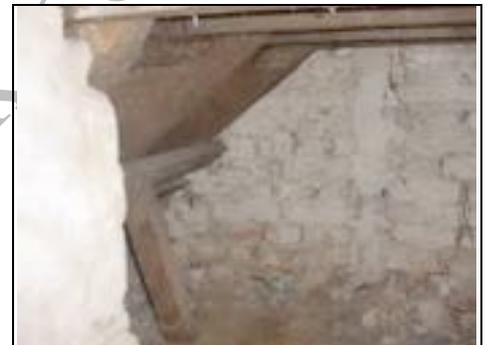
Some of the staircases had movement in them.

Stairs need securing

**ACTION REQUIRED:** Please see our comments in the Executive Summary with regard to the staircase.

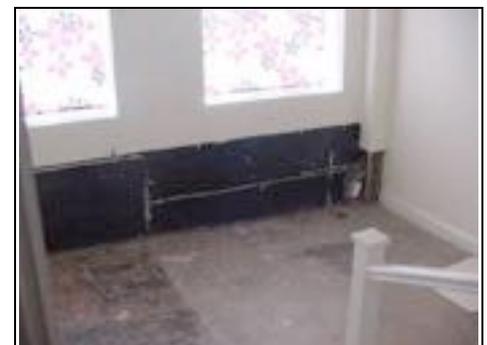
The property has two kitchens. The kitchen to the left side is unfinished and there is a small utility area. There is also a kitchen in the right side in the modern part of the property.

Kitchen unfinished in left side/annexe

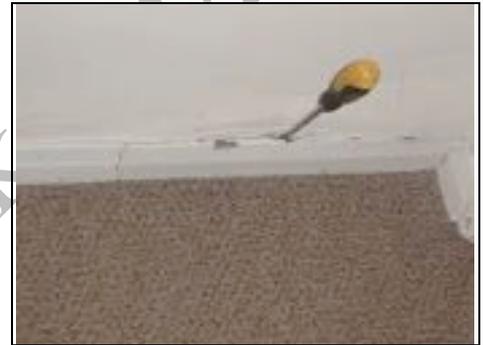
We would particularly check in the utility room whether there is an excess of dampness as there may be wet rot or dry rot in this area.

Possible wet rot or dry rot in utility room in left building

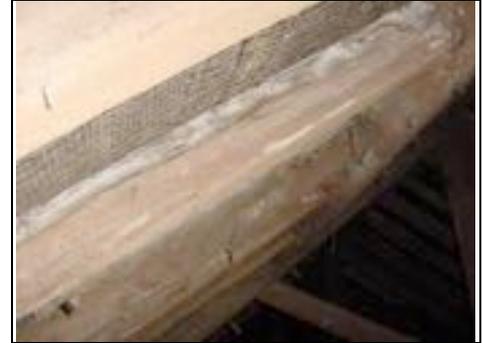
The roof is the main area that we look for woodworm. Within the roof we found the usual visual signs of past woodworm activity. The difficulty is establishing whether the woodworm is now active. We believe conditions are favourable for woodworm underneath the floors and also within the roof due to the insulation, which is why we are recommending ventilation is improved in this area.

Woodworm

**ACTION REQUIRED:** Add ventilation. We would also recommend removing some of the insulation for inspection of woodworm. The building may perform better with less insulation in it.

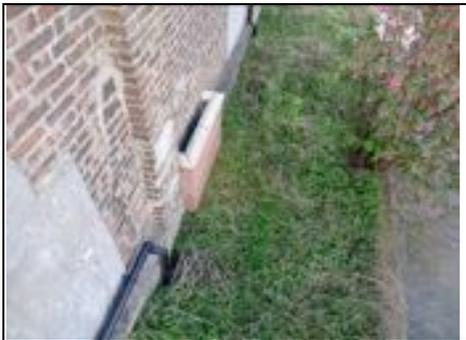
This is adjacent to the River Waring. As you are aware there is flooding in the area. We can see what the existing owner has done to limit the water getting into the cellar. We also believe that a sump pump should be added in this area.

Window of cellar blocked to stop flooding

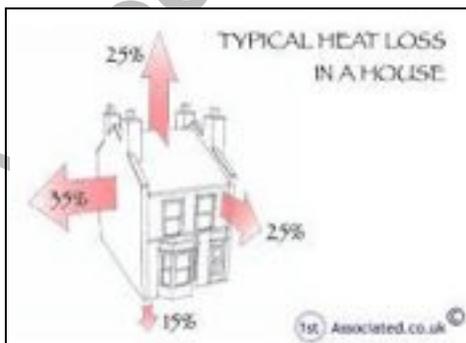
Current Building Regulations require insulation of 300mm. In this instance the loft is over-insulated and ventilation is required.

Typical heat loss

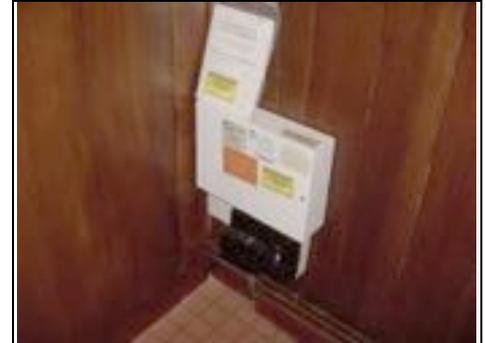
An alarm box was noted to the right side of the property and the security alarm was on when we entered this property as you know as you managed to turn it off. A good alarm system should not only help reduce break-ins but also help reduce your insurance. We are not experts in this field and therefore cannot comment further.

Alarm system

**ACTION REQUIRED:** Further information should be obtained from the vendor and the installer.

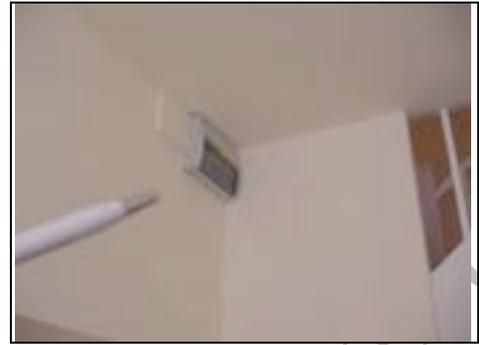
The electric fuses and consumer units were located in the front right room of the right side of the building which looked 1980's. To the left side/annexe the electrics are 1990's/2000's in proposed kitchen area and better are now available.

Fuse Board to left building

**ACTION REQUIRED:** As the property is changing occupancy an Institution of Engineering and Technology (IET) test and report and any recommendations should be carried out by a NICEIC registered, or equivalent, approved electrical contractor or similarly approved.

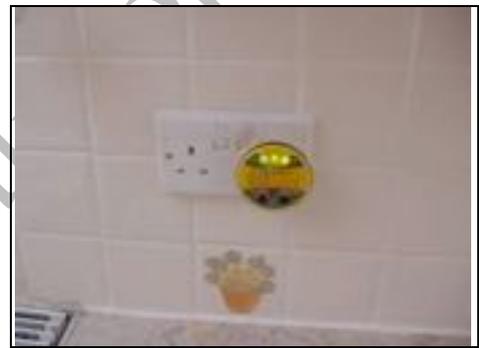
We carried out an earth test in the kitchen area to the socket point that is normally used for the kettle, this proved satisfactory.

Earth test

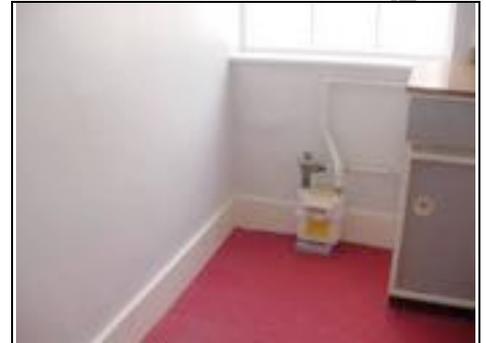
We are advised that the property has mains gas.  
The consumer unit is located in the small rear right room.

Gas in small rear right room

**ACTION REQUIRED:** As a matter of course it is recommended that the entire gas installation is inspected and made good, as necessary, by a Gas Safe registered contractor. Thereafter the installation should be serviced annually.

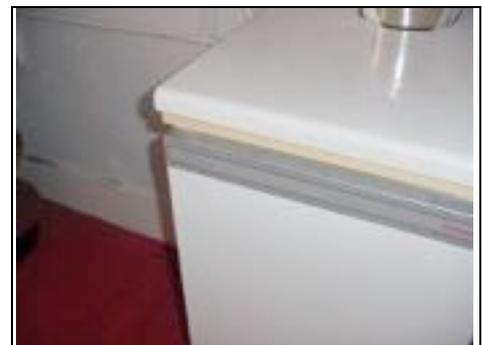
One boiler for the whole property?

Boiler in small rear right room

We would recommend having a separate boiler if you do intend to have these as separate buildings.

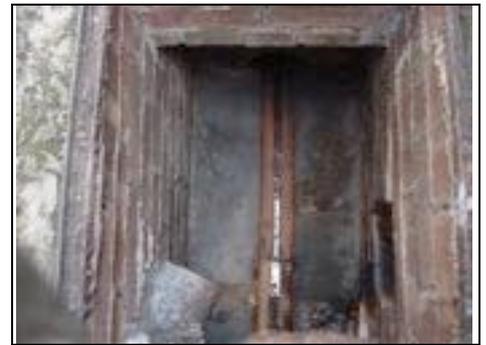
We duly lifted the cover and found it to be free flowing at the time of our inspection.

From what we could see it is brick built.

Manhole in courtyard

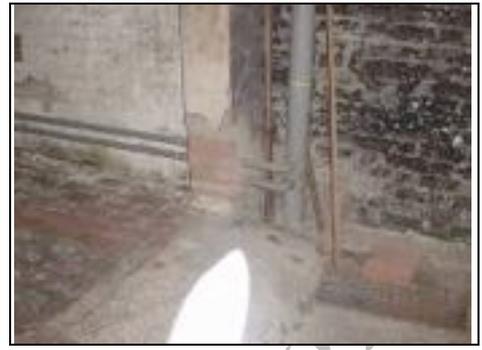
We were unable to lift the manhole therefore are unable to comment.

Manhole in garage

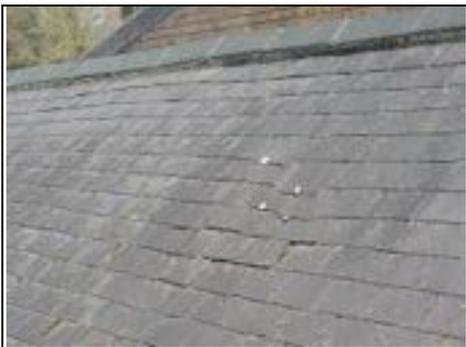
We would term the garage as being in a dilapidated state with roof leaks visible which do look to have been repaired particularly with regard to the flashings to the valley gutter. Please see our comments in the Executive Summary and Roof Coverings Section.

Tingles to slates on garage roof

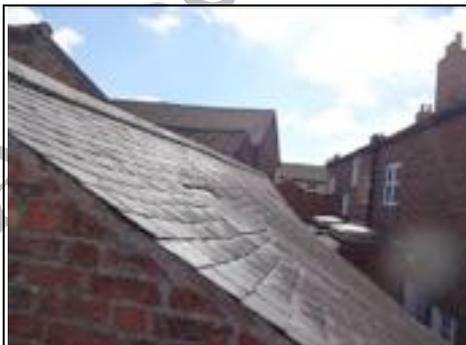
Twist in rear slate roof over garage

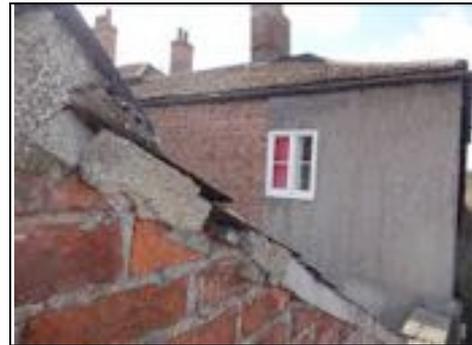
Verge needs repointing to the slates of the garage roof

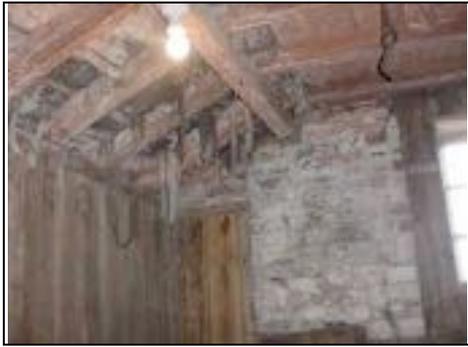
Damage to garage/workshop roof

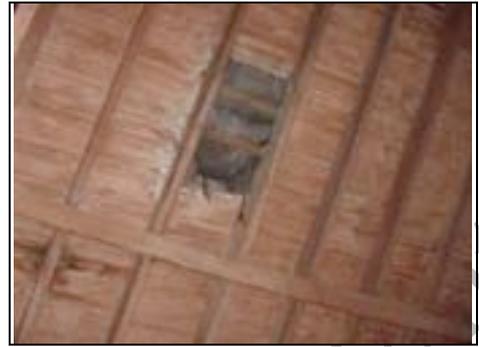
Damage to garage/workshop roof

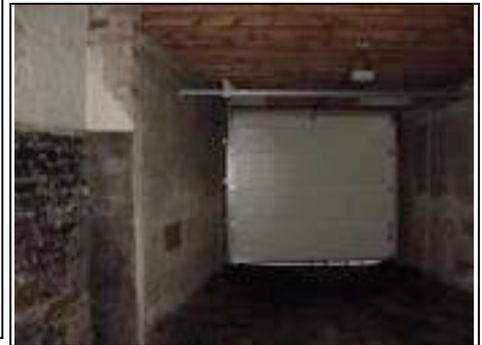
Note, the driveway slopes towards the garage and we would expect rainwater to run under the garage door. We would recommend a running gully is added.

Rainwater runs under garage door

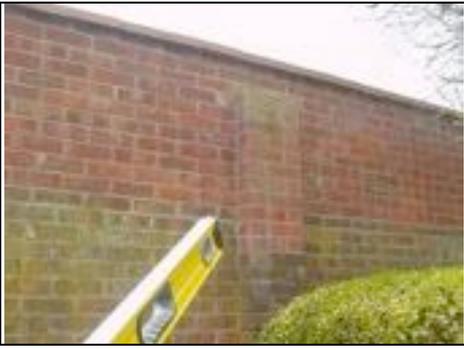
Wall around property repaired and extended

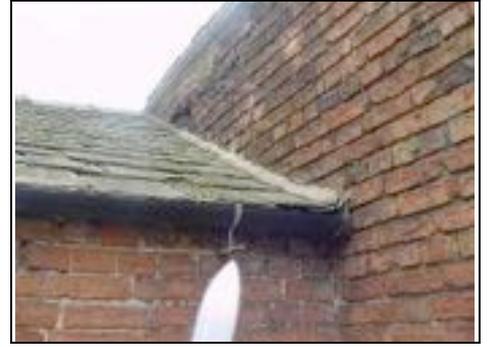
Cement mortar to flashing of stables

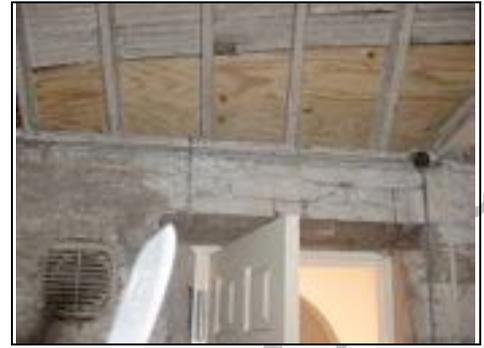
Timber lintel in coal bunker which indicates there may be other timber lintels
