RESIDENTIAL BUILDING SURVEY

Barnsley

Mrs X

INDEPENDENT CHARTERED SURVEYORS

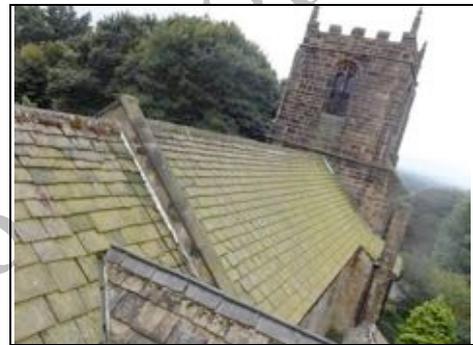
Parapet walls are allowing dampness in
Aerial view – 360 photo

ACTION REQUIRED: Replace felt and Flashband with lead flashing. This work can be carried out over the next few years with the exception of the Flashband to the pitched roof to the nave end which looks to be allowing water in and the rear parapet wall to the front of the chancel which looks to be deteriorating rapidly.

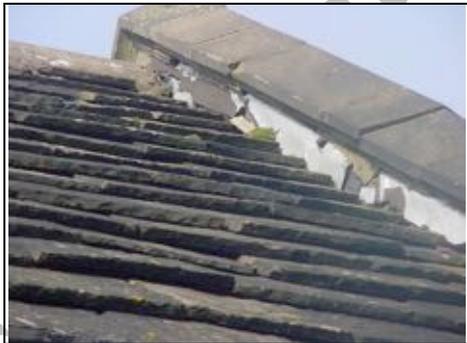
Flashband flashing deteriorating on chancel roof

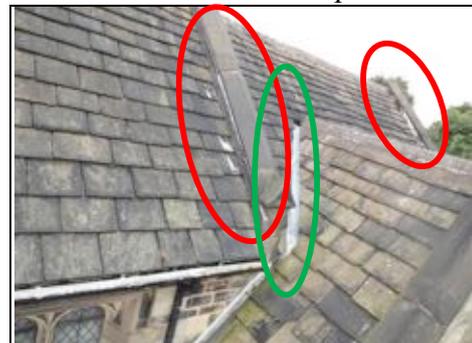
Two main parapet walls with Flashband repairs (red ovals) and valley gutter (green oval)

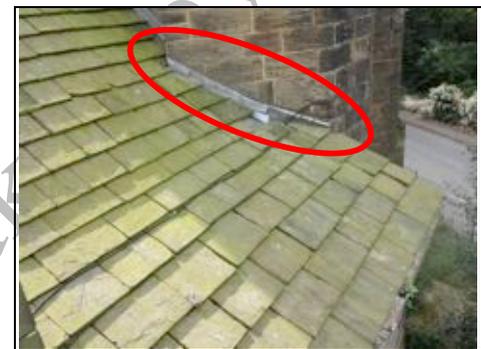
We also noted that some of the metal flashings are coming away and need to be checked, for example around the Tower to the rear.

Flashing coming away around Tower

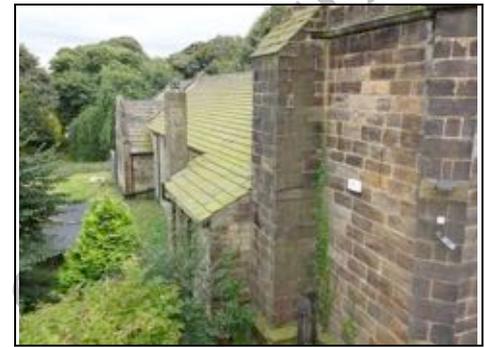
There seems to be problems with the roof adjacent to the tower allowing dampness in to the store room below, also causing staining on the exterior of the property. As this is a store room you may wish to leave this work to a later date, the longer it is left of course the more expensive it may be to repair. We were advised by the existing owner that they had not carried out any work in that area.

Roof adjacent to tower covered with moss

ACTION REQUIRED: Check roof adjacent to the Tower and replace stone slabs as necessary, including the battens and fixings beneath and install a lager hopper head.

ANTICIPATED COST: In the region of £2,500 to £5,000; please obtain quotes. Again scaffolding is likely and we recommend you have your own tower scaffold.

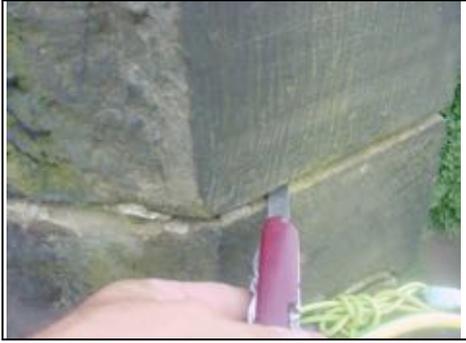
The property has coursed stonework with relatively thin joints. Originally the pointing would have been a lime mortar with gilleting (more about this in the Walls Section). This has then been repointed incorrectly with a cement mortar, which in turn causes deterioration.

Weathering stonework

ACTION REQUIRED: General repairs to the stonework. Repointing in a lime mortar needs to be carried out over many years.

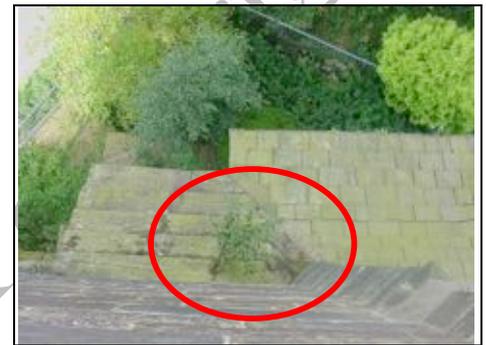
Some of the detailing on the property means there are ledges. Ledges allow water to sit on it, which means you then have lichens, moss, plant life and vegetation growing on them which can cause deterioration to the stonework.

Bushing growing to the rear

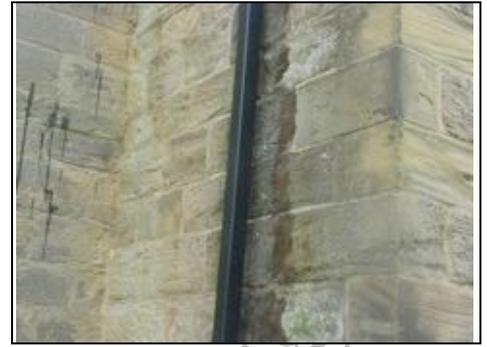
We noticed that some of the roofs seems to be discharging rainwater down the property. It may be because the gutters are full and we recommend these are cleared. It may equally be there is simply too much water for these gutters and hopper heads. We can see staining particularly to the rear of the church.

Water discharging down rear left wall next to chimney

ACTION REQUIRED: We recommend the gutters are cleaned.

You need to stand outside next time heavily to assess that all the rainwater is getting away from the building adequately. Repair and amend as required.

ANTICIPATED COST: In the region of £750 to £1,500 for gutter cleaning, gutter re-aligning, possibly new guttering and possible larger hopper head. Please obtain quotations.

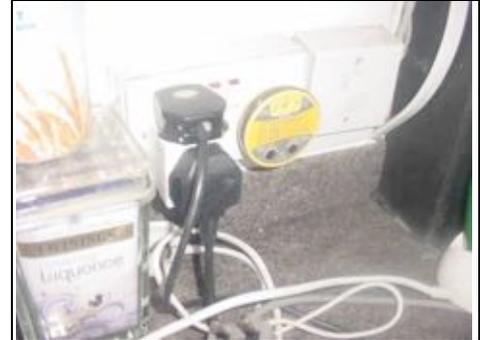
The electrics are dated and failed our earth test in the kitchen. We think the electrics are complex and have been built up over the years. The existing owners have built up a knowledge of these and you need to have a tour specifically noting down what light points refer to and the fuseboard refers to what if you do decide to purchase the property.

Failed earth test

ACTION REQUIRED: Replace fuseboard.

We recommend an Institution of Engineering and Technology (IET) test and report to be carried out by an NICEIC registered and approved electrical contractor or equivalent.

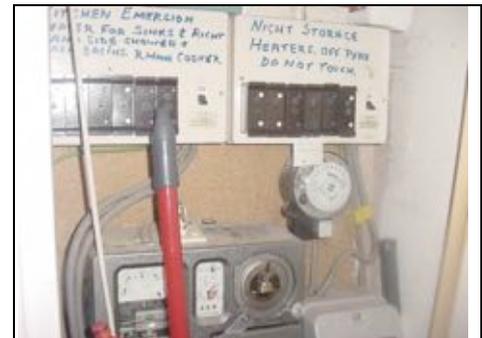
The electrics are a mixture of single phase and three phase, possibly because of its original commercial background. The present owner advised that the Brownies and Guides, etc used to come and stay over at the property when it still had a communal use before it became a residential property.

Dated electrics

ANTICIPATED COST: £500 to £1,000 plus any work recommended; please obtain quotations.

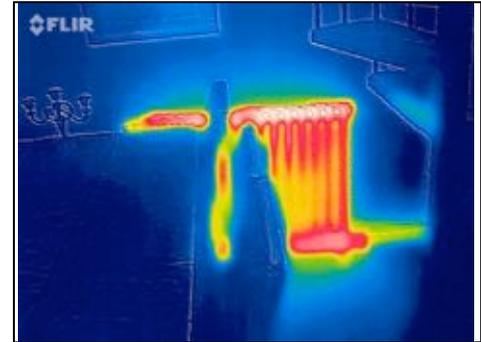
Although the owner's switched the heating on during our survey which did warm up the old school/hospital style radiators we are not sure whether it would give sufficient heat for the building of this height.

Generally with stone construction the heating would need to be turned on constantly for the building as a whole to warm up which could be very costly.

Thermal image photograph – the red showing heat loss from radiator

ACTION REQUIRED: Your legal adviser to ask for copies of the owner's energy bills and also discuss whether they have been at the property during the winter months.

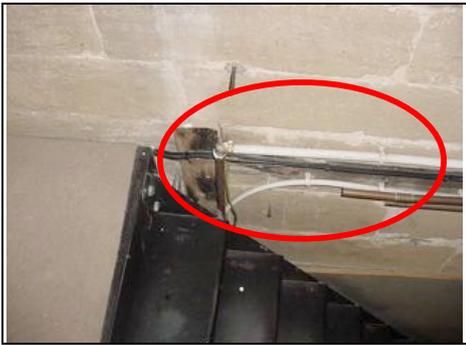
There are copper pipes at the top of the metal staircase to the first floor that are going nowhere and look to have been cut off. On our second visit we discussed this with the owner who advised that there had been water tanks in the first floor bedroom area within the Tower and these had been removed, yet the pipes still remain.

Pipes cut off at top of metal staircase to first floor

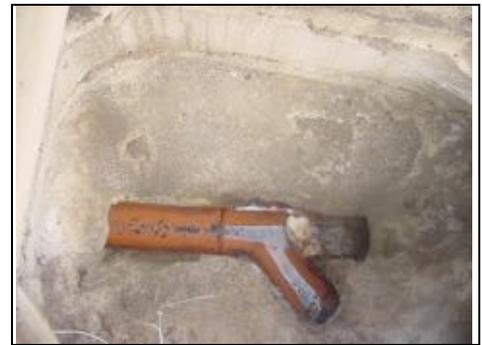
The one manhole of the two that we did manage to lift showed that the drains were fairly shallow and there was some waste matter sitting in the drain, although it does look as though it would flush away. Having said that, the manhole did look to have been fairly recently opened.

Manhole slightly blocked

ACTION REQUIRED: We always recommend septic tanks are emptied before you legally commit to purchase the property so they can be inspected. We were advised that this was a modern glass reinforced plastic (GRP) septic tank as opposed to an old brick one.

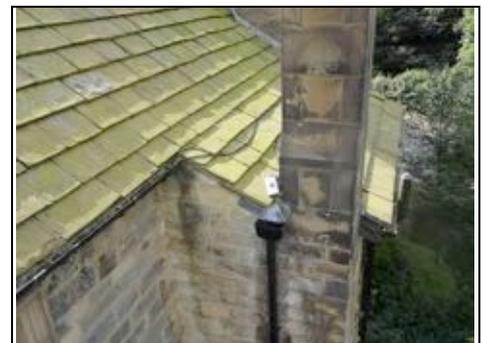
Base of chimney, with overflowing hopperhead to the side.

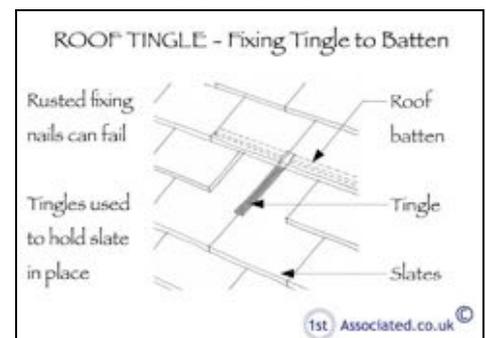
Lead tingles

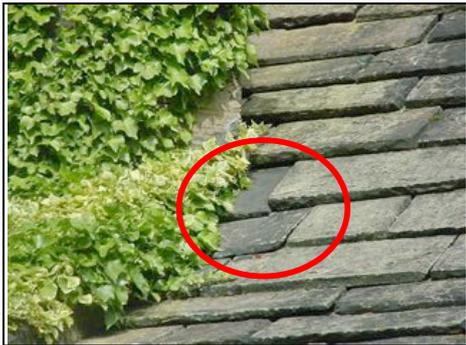
Damaged slabs have been replaced over entrance porch with a thinner slab

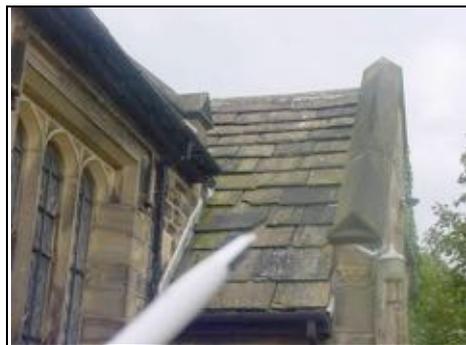
The main roof is pitched and clad with stone slabs. From ground level this looks in slightly below average condition considering the roofs age type and style. We noted some lead tingles.

Lead tingles

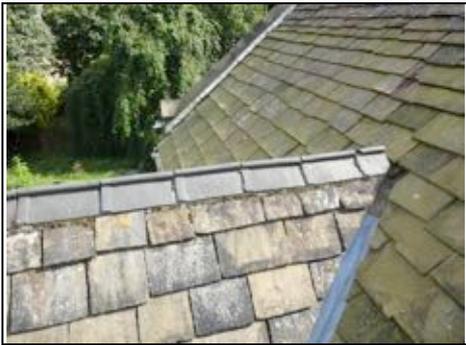
Repairs to valley gutters
Aerial view – 360 photo

ACTION REQUIRED: Specifically ask the owners what valley gutters they have replaced and repaired over the years and ideally get receipts in relation to the work.

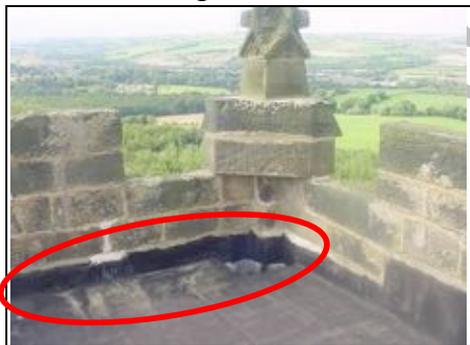
Problems with flashing on roof

The flat felt roof has been repaired many times and we can see there are problems relating to the flashings which have been repaired.

ACTION REQUIRED: Repair flashings, parapets and ad hoc repointing.

Also in the not too distant future we recommend a protective paint is added to the roof to help stop deterioration and/or the felt is replaced with a high performance mineral felt, such as an Elastomeric felt.

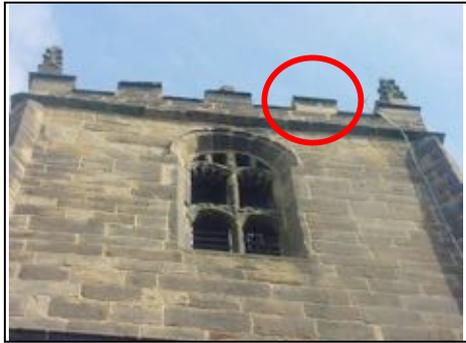
Old repairs to parapet visible

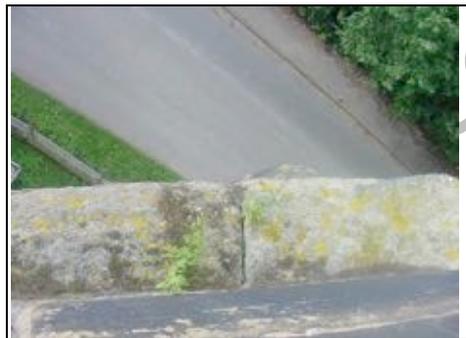
There is a ledge to the base of the parapet wall that has plants growing out of that need clearing. We can also see the joints need repointing.

Ledge joints need repointing and growth of vegetation

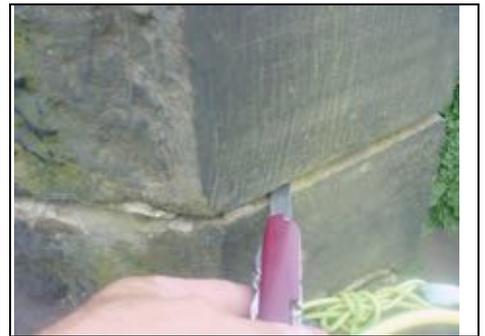
Repointing needed

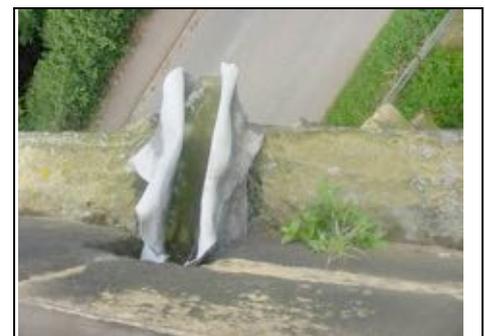
We would also draw your attention to the rainwater gully which discharges rainwater down the side of the building.

Rainwater gully discharges rainwater down wall

Water is discharging from the gully on the Tower all the way down the stonework to the base, causing deterioration.

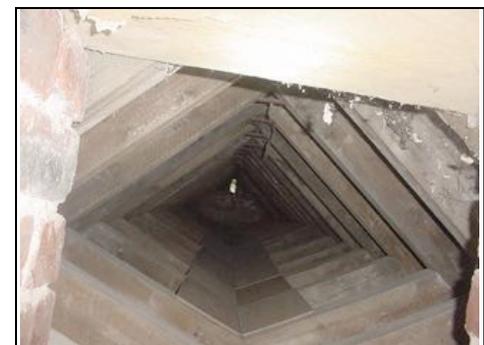
Last bit of roof over Chancel inspected by torchlight only, limited our view

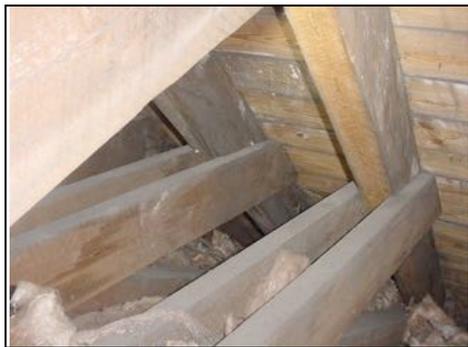
In addition, we are concerned with this type of roof about the weight of the timbers. There is a considerable amount of timber in the roof, far more than we would use today, or in fact has used for several decades. This weight of timber, together with the weight of the stone slab on the roof could lead to damage to the walls, pushing them out of alignment.

Substantial timber trusses, spaced approx. 350mm apart (not measured)

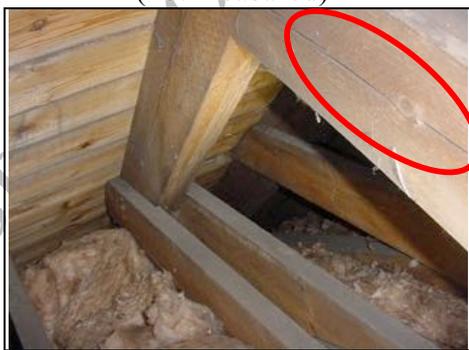
Splits in collar.

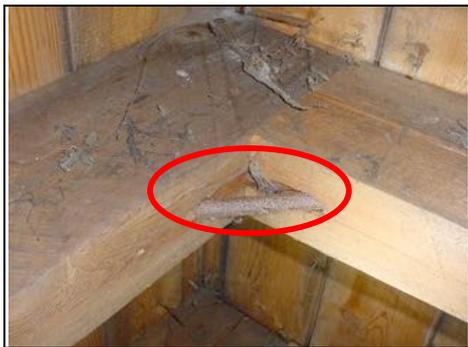
Also within the roof there are metal ties to the ridge and tie bars both vertically and horizontally. We think these were added at the time of construction, although it is difficult to be certain. We looked for deterioration of these and there has been some rusting but there is no physical evidence of failure, by this we mean rusting through within the roof.

Rusting metal tie bar

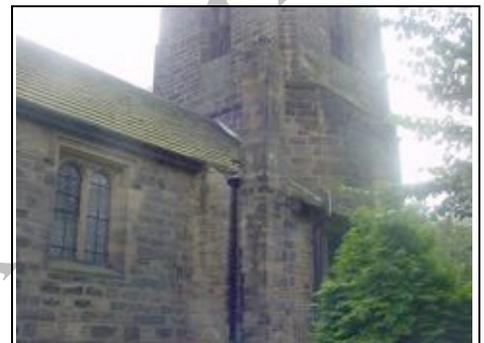
We can see some pattern staining to the rear of the property around the chimney area, which indicates that the gutters and hopper heads are overflowing.

Hopper head and gutters discharge

We also recommend that the gutters and downpipes are cleaned out, the joints are checked and the alignment checked to ensure that the gutters fall towards the downpipes.

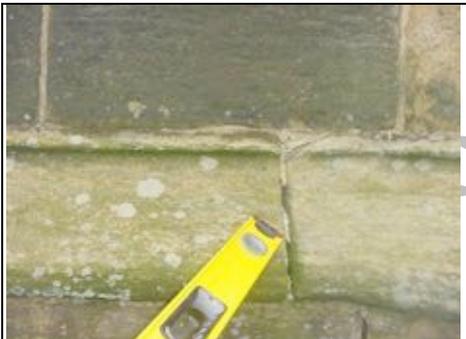
We would comment that the mortar pointing has been repointed in some areas in cement and it has weathered badly. There is a growth of moss, lichens and vegetation such as ivy on the stonework, including the ledges, which are ideal places for plant life to grow.

Weathering to stonework and deteriorating pointing

ACTION REQUIRED: Repoint where mortar is weathered and remove any cement mortar. Identify deteriorating stonework and clear vegetation from the structure, particularly on the ledges.

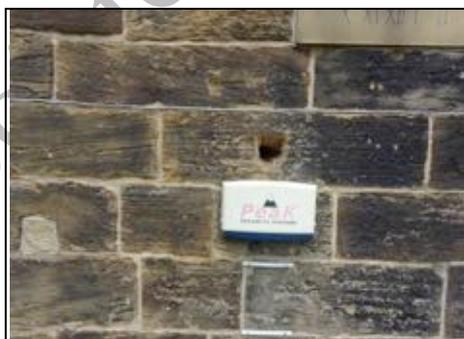
Repairs to stonework generally to south face
(and access hole for wasps!)
Aerial view – 360 photo

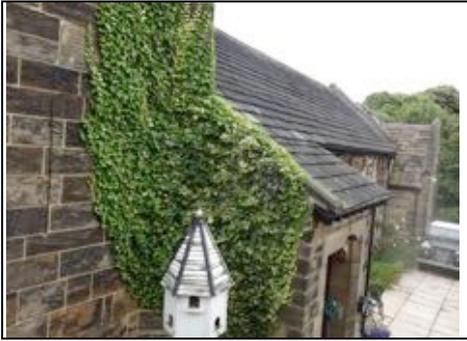
Ivy growing on walls
Aerial view – 360 photo

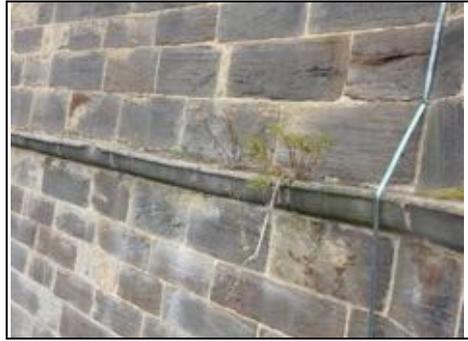
Vegetation growing on wall ledges
Aerial view – 360 photo

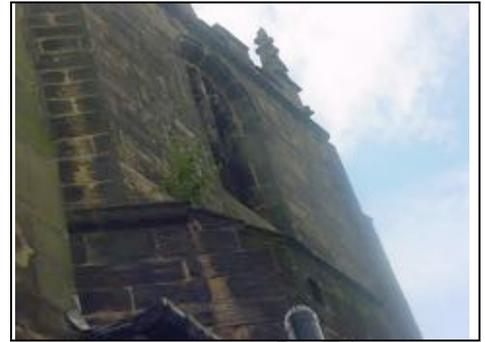
Tree growing to rear

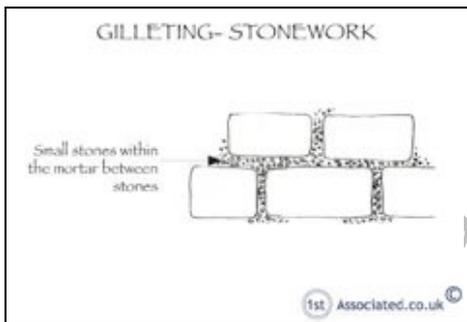
Some of the older mortar has gilleting into the mortar.

Gilleting stonework

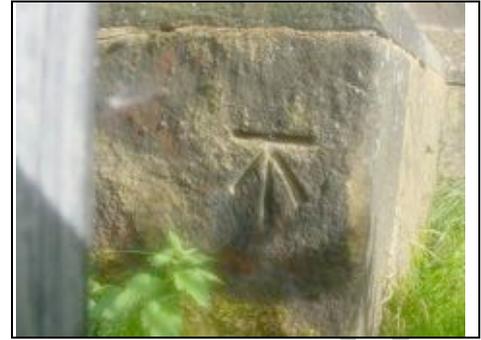
We noted a Datum/Bench Mark on the stonework, which are the chiselled in horizontal marks that surveyors made in stone structure, which gives levels for the building as a whole and usually its relation to seal level is known.

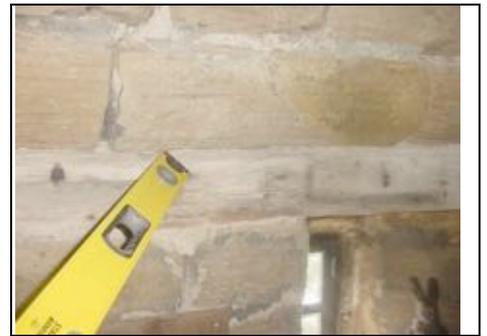
Timber Wooden lintel

Finally, the external walls have been inspected visually from ground level and/or randomly via a ladder. Where the window and door lintels are concealed by stonework / plasterwork we cannot comment on their construction or condition. In buildings of this age timber lintels and stone lintels are common, which can be susceptible to deterioration that is unseen, particularly if in contact with dampness.

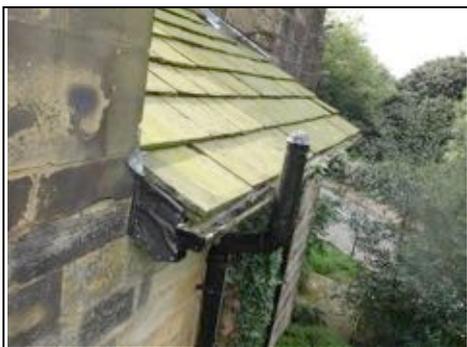
The fascias and soffits are timber where we can see them, however a number have been covered over with what looks to be a plastic material and we consider this a DIY repair.

DIY plastic repair to fascia board

ACTION REQUIRED: You need to speak to the owners and ask them why they have covered these areas with plastic; we assume they have rotten away. It does seem a strange repair and there may be some other reason for repairing in such a manner.

ANTICIPATED COST: Budget for replacement, we would anticipate costs for replacement fascias and soffits to be £1,000 to £5,000; please obtain quotes. Sorry to be so broad with this figure but we simply cannot see them due to the plastic coverings.

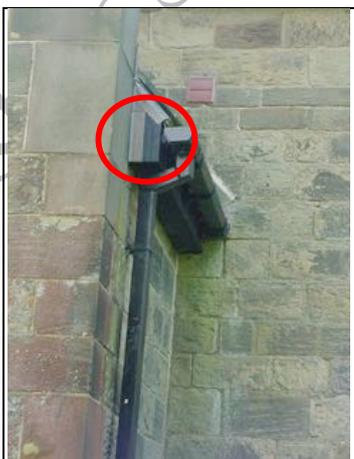
There are also Flashband repairs, which we consider a temporary material.

Flashband repair to fascia on north side

Flashband is a sticky backed felt, which is best used for temporary repairs only.

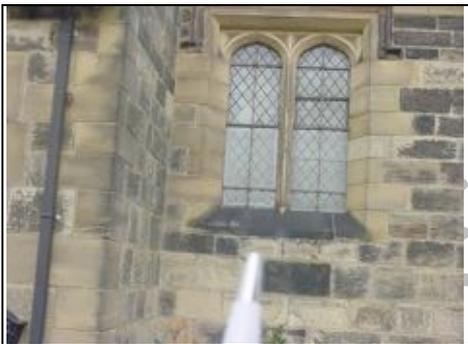
Perpendicular windows to front/south side have been repaired

The clean lines on the Perpendicular windows indicate they have been repaired, probably during the Victorian Revival period of 1870-1900's.

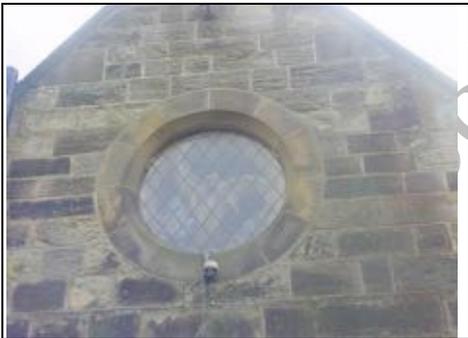
As with all older properties there are some mysteries, such as the circular window to the north side and the older window to the front right side, which we would have to do further investigation to establish when this was.

Curvilinear window. We were unable to view this very well due to having a plastic protection on it

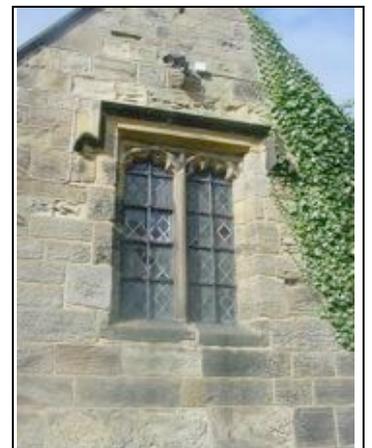
Older window to front right side

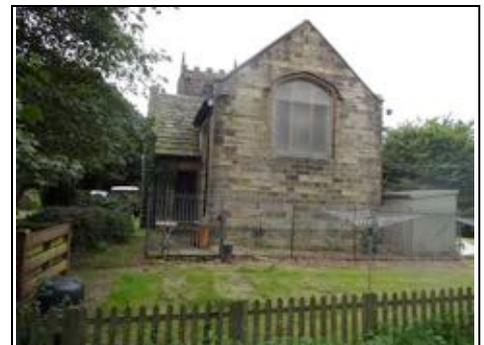
We would specifically comment that with larges windows such as these it is important that the lintels are in good condition as you can get bowing.

Perpendicular stained glass window externally covered with plastic

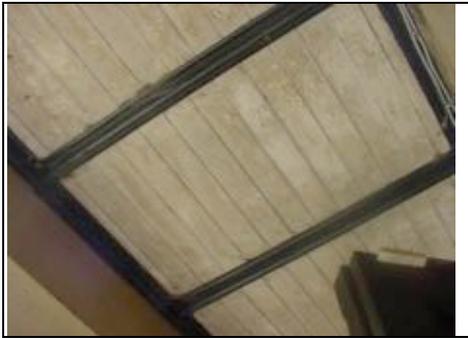
Some of the barrel ceilings / wagon roof are in poor condition

We note that some of the ceilings are damaged and are deteriorating, for example around the Nave and Chancel where they meet and also in some of the store room areas.

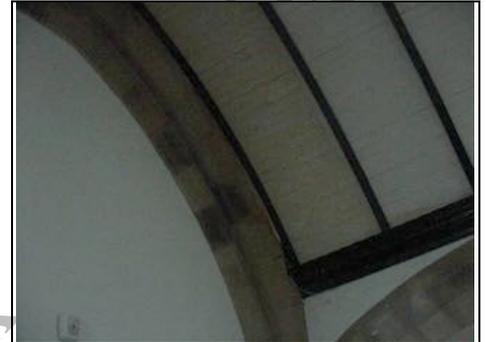
We noticed a difference in colour on the barrel roof where the Chancel roof meets the Chancel Arch as it enters the Nave. We believe some sort of dampness is getting into this area.

Difference in colour on barrel roof believed to be due to dampness in this area

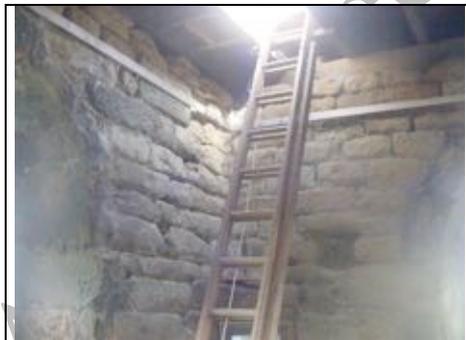
We noted a bracing bar in the Tower at the very top.

Bracing running around the top of the Tower

ACTION REQUIRED: Your solicitor to specifically ask the owners if they have any information with regard to this.

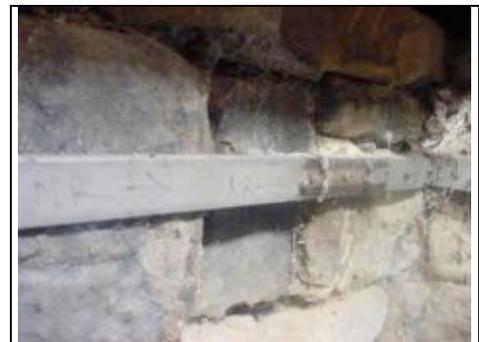
Close up view of the bracing bar

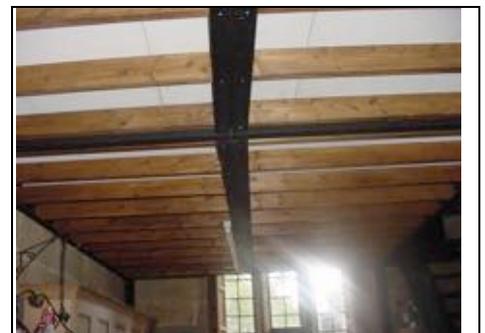
Underside of first floor, see how the steel beam twists with the timbers in it

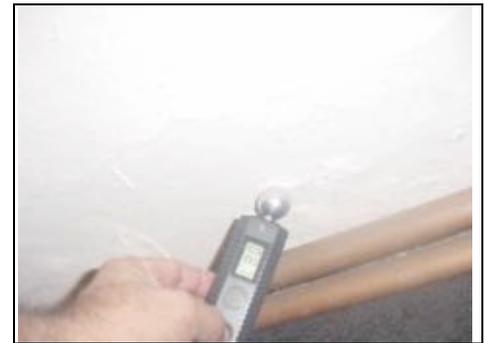
A visual inspection and tests with a moisture meter have been taken to the perimeter walls. In this particular case we have found significant rising damp.

Testing for rising damp

ACTION REQUIRED: Please see the Executive Summary.

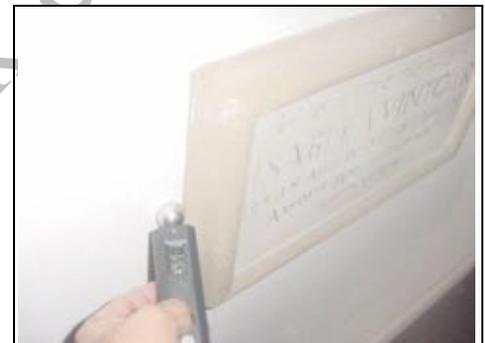
We used a resistance meter on the external walls. We found some dampness, but this is in line with what we would expect for this age, type and style of property.

Testing for lateral dampness next to Isabel Wintour sign

ACTION REQUIRED: Please see our comments in the Executive Summary about rising damp.

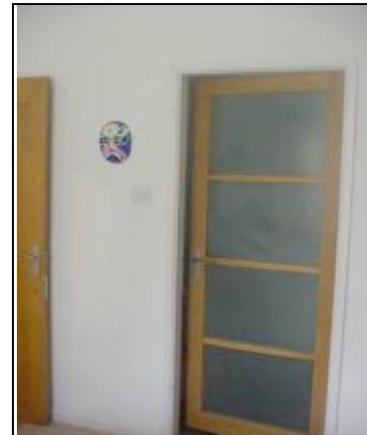
The doors are a mixture of what we would term as older style doors, modern look older style wooden panel doors and modern look glazed doors. We would not see any safety kite mark on the glazed doors.

Glazed door

ACTION REQUIRED: Ask the existing owners whether this is safety glass and are they fire doors. If they are not safety glass we recommend you replace the glass accordingly.

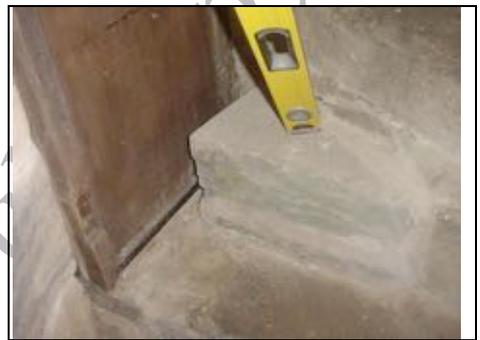
Stone steps to west side of Tower, level indicating new bit of stone added, meaning the door can no longer open

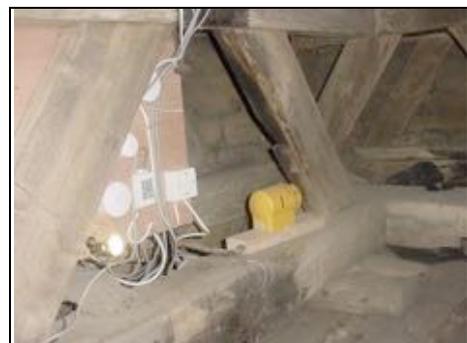
The roof is the main area that we look for woodworm. We have not had access to the roof space in this instance. We did have a good look at the timbers in the Belfry and there were signs of woodworm in there but having said that most old properties would have woodworm. In many properties there is an element of woodworm that is not active but the roof would need to be opened up to check.

Timber in the Belfry

ACTION REQUIRED: We would not recommend buying the property until you have viewed the roof. It is impossible to be 100 per cent certain unless the roof is cleared of fixtures and fittings for a full inspection. We are happy to return to check this area if it is opened up.

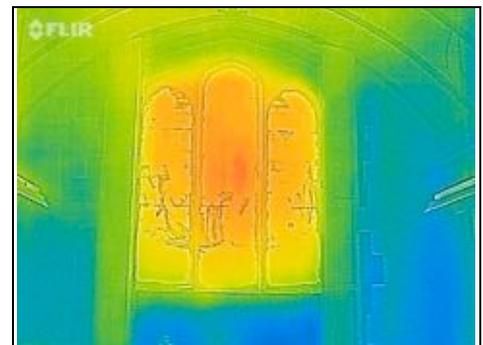
The adjacent photo shows heat loss through one of the windows.

Thermal imaging photo showing heat loss through the window

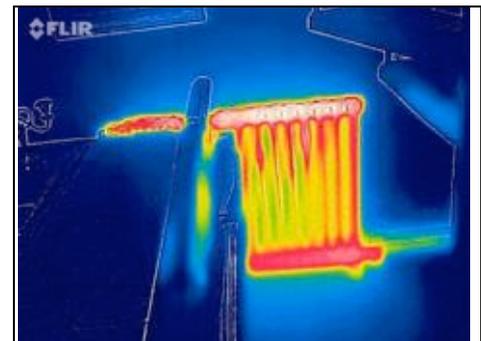
Thermal imaging photo of a radiator

We thermal imaged the radiators working but there is a large area of building compared with the number of radiators/heaters.

We recommend that you insist on having copies of the invoices and bills paid for oil and electricity during the years the owners have been present in the property to try and establish how much your costs are likely to be as they could be considerable.

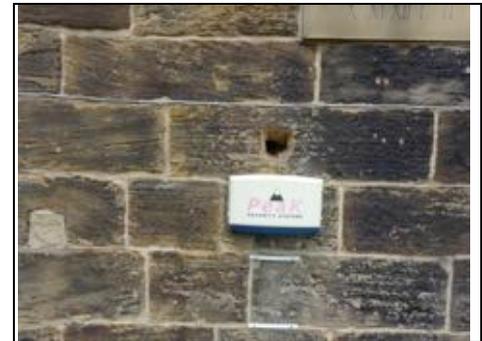
A security system has been installed. A good alarm system should not only help reduce break-ins but also help reduce your insurance. We are not experts in this field and therefore cannot comment further.

Alarm box on church tower
with entrance for wasps just above!
Aerial view – 360 photo

ACTION REQUIRED: Further information should be obtained from the vendor and the installer.

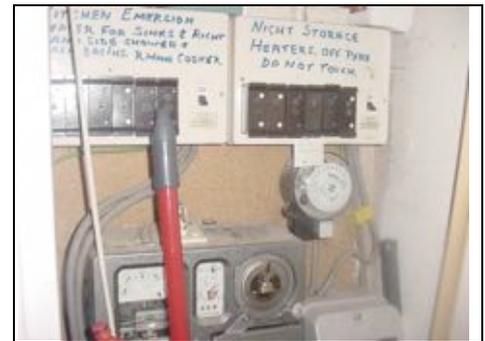
The electric fuses and consumer units are a mixture of single and three phase, due we believe to its past commercial background.

Dated electrics

ACTION REQUIRED: Please see our comments in the Executive Summary.

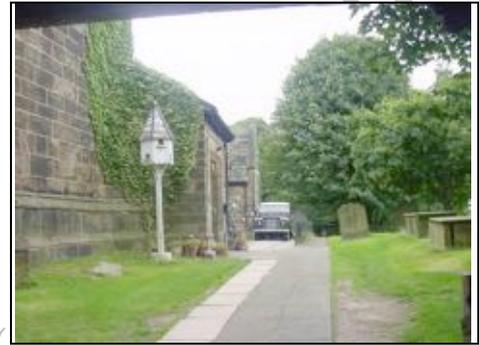
You need to check and confirm exactly what your access rights and parking rights are to this property and indeed for the garden as a whole.

Parking and access

ACTION REQUIRED: Please see our comments in the Executive Summary about access.

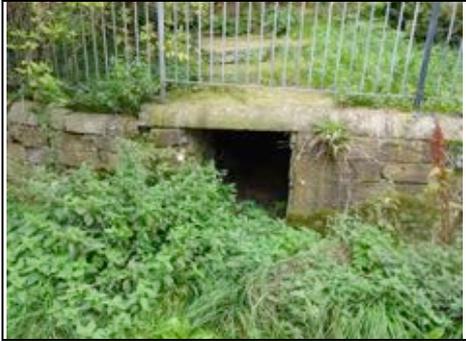
We noticed this opening on the roadside. On our second visit we went inside and it was sealed by brickwork. It looks like it may be an entrance to an old crypt or underground access of some kind.

Opening on the roadside

ACTION REQUIRED: As the owners if they know what this relates to.

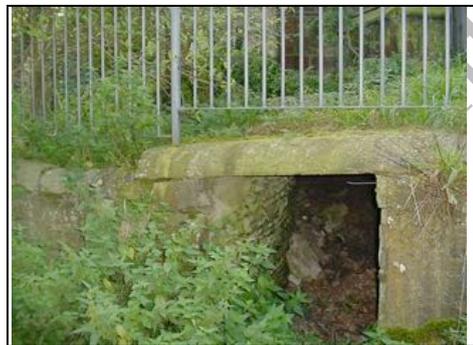
Close up – sealed by brickwork

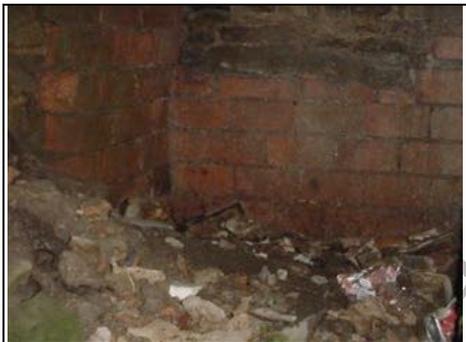
Close up of brickwork at end

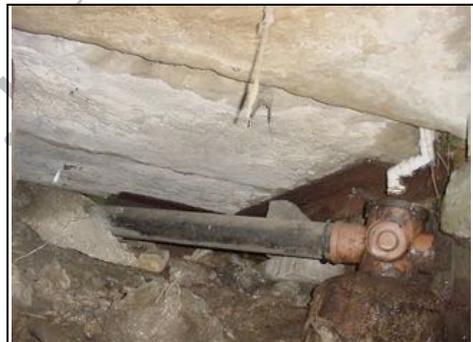
We did notice what looks to be a sump pump or gas supply under the stones.

Sump pump or gas supply under the stones

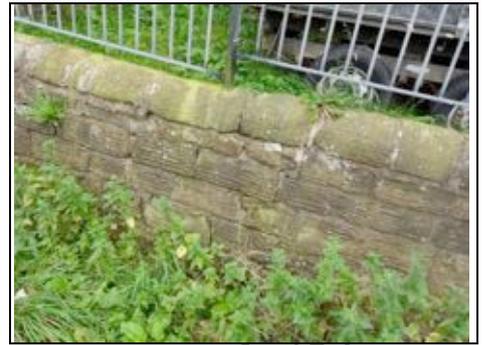
We can see movement in the boundary wall and you need to ascertain whether this is your responsibility.

We can see movement in the boundary walls – are these your responsibility?

ACTION REQUIRED: Your legal adviser to check and confirm.

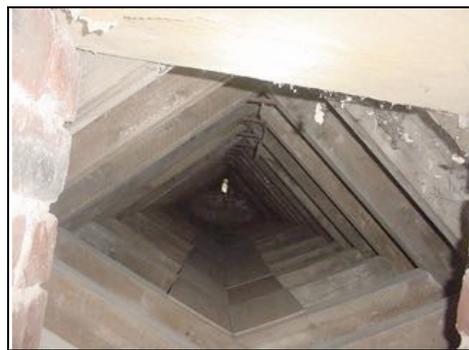
- 1) We were only able to inspect the roof above the Nave and only by torchlight in the Chancel roof.

Last bit of roof over Chancel inspected by torchlight only, limited our view
